**Mountain Ash Limited Partnership Aggregate Operation
NW and SW 31-26-03 W5M, Rocky View County, Alberta**

Visual Appraisal

**February 2020
SLR Project No.: 212.06650.00003/008**

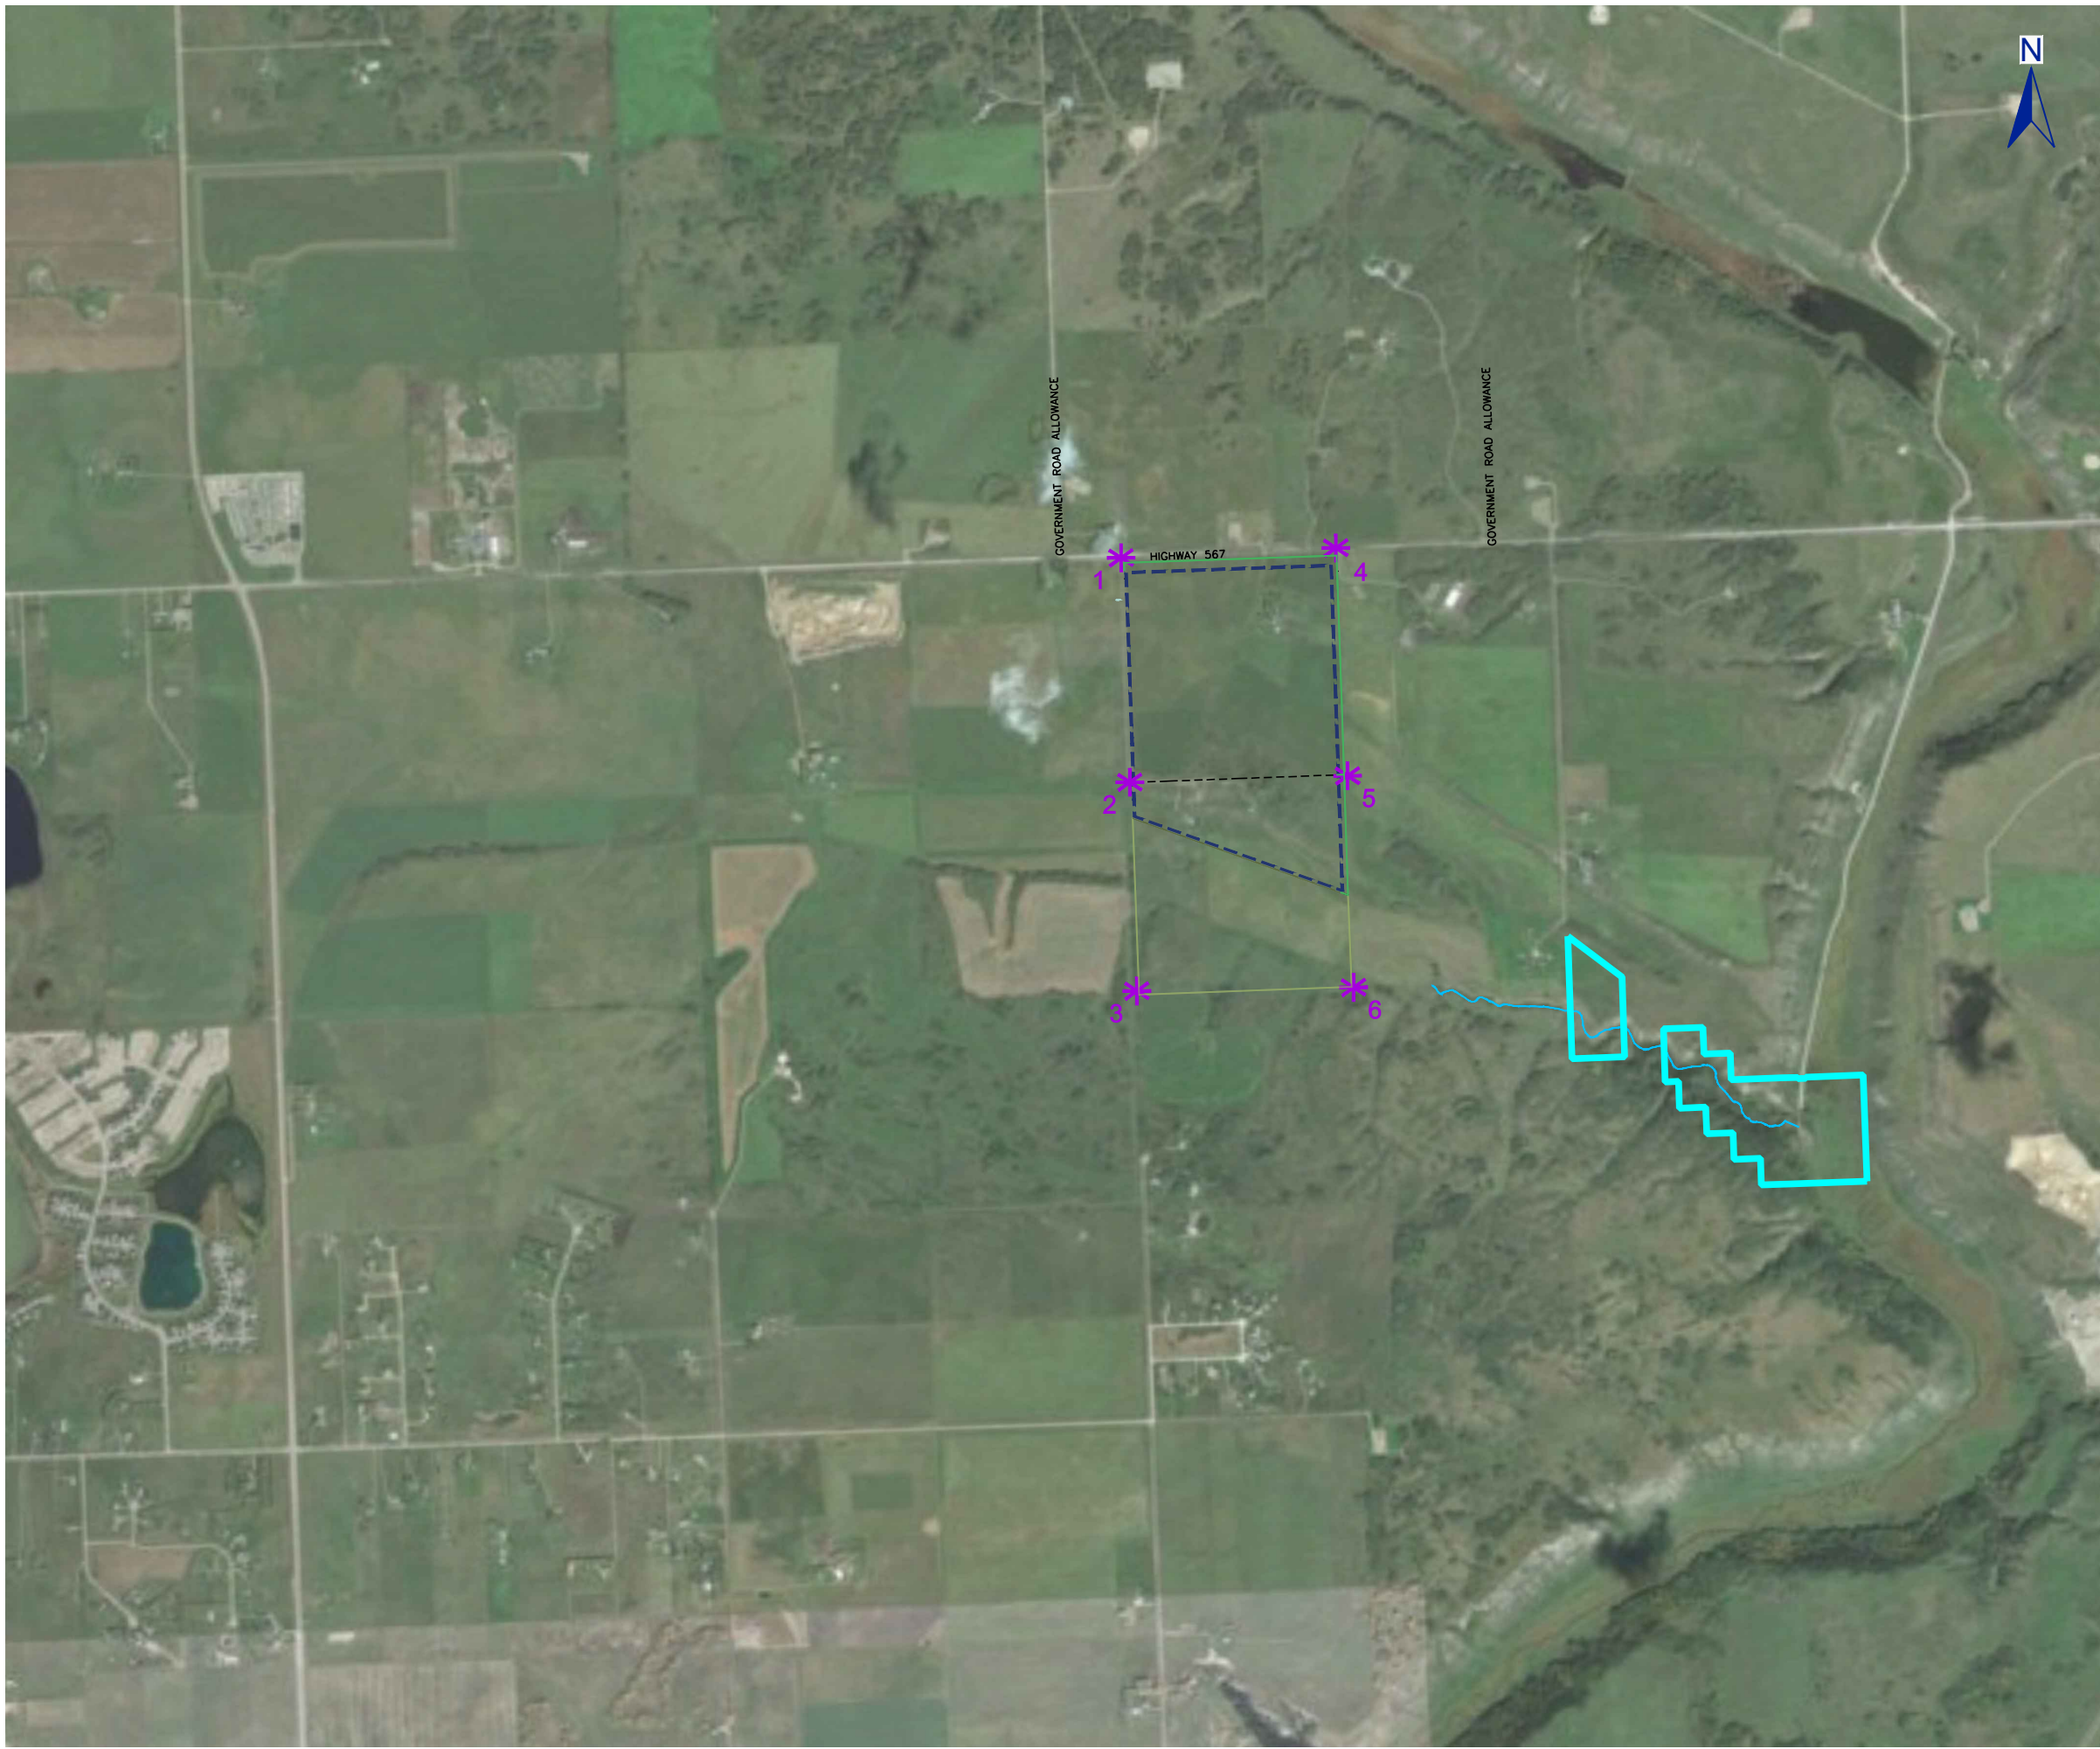
The initial ZTV has been combined with property boundary information and reviewed against aerial photography (refer to Drawing 2) and other mapping datasets, such as the Rocky View County land use zones, to identify potential visual receptors and suitable observation viewpoint locations.

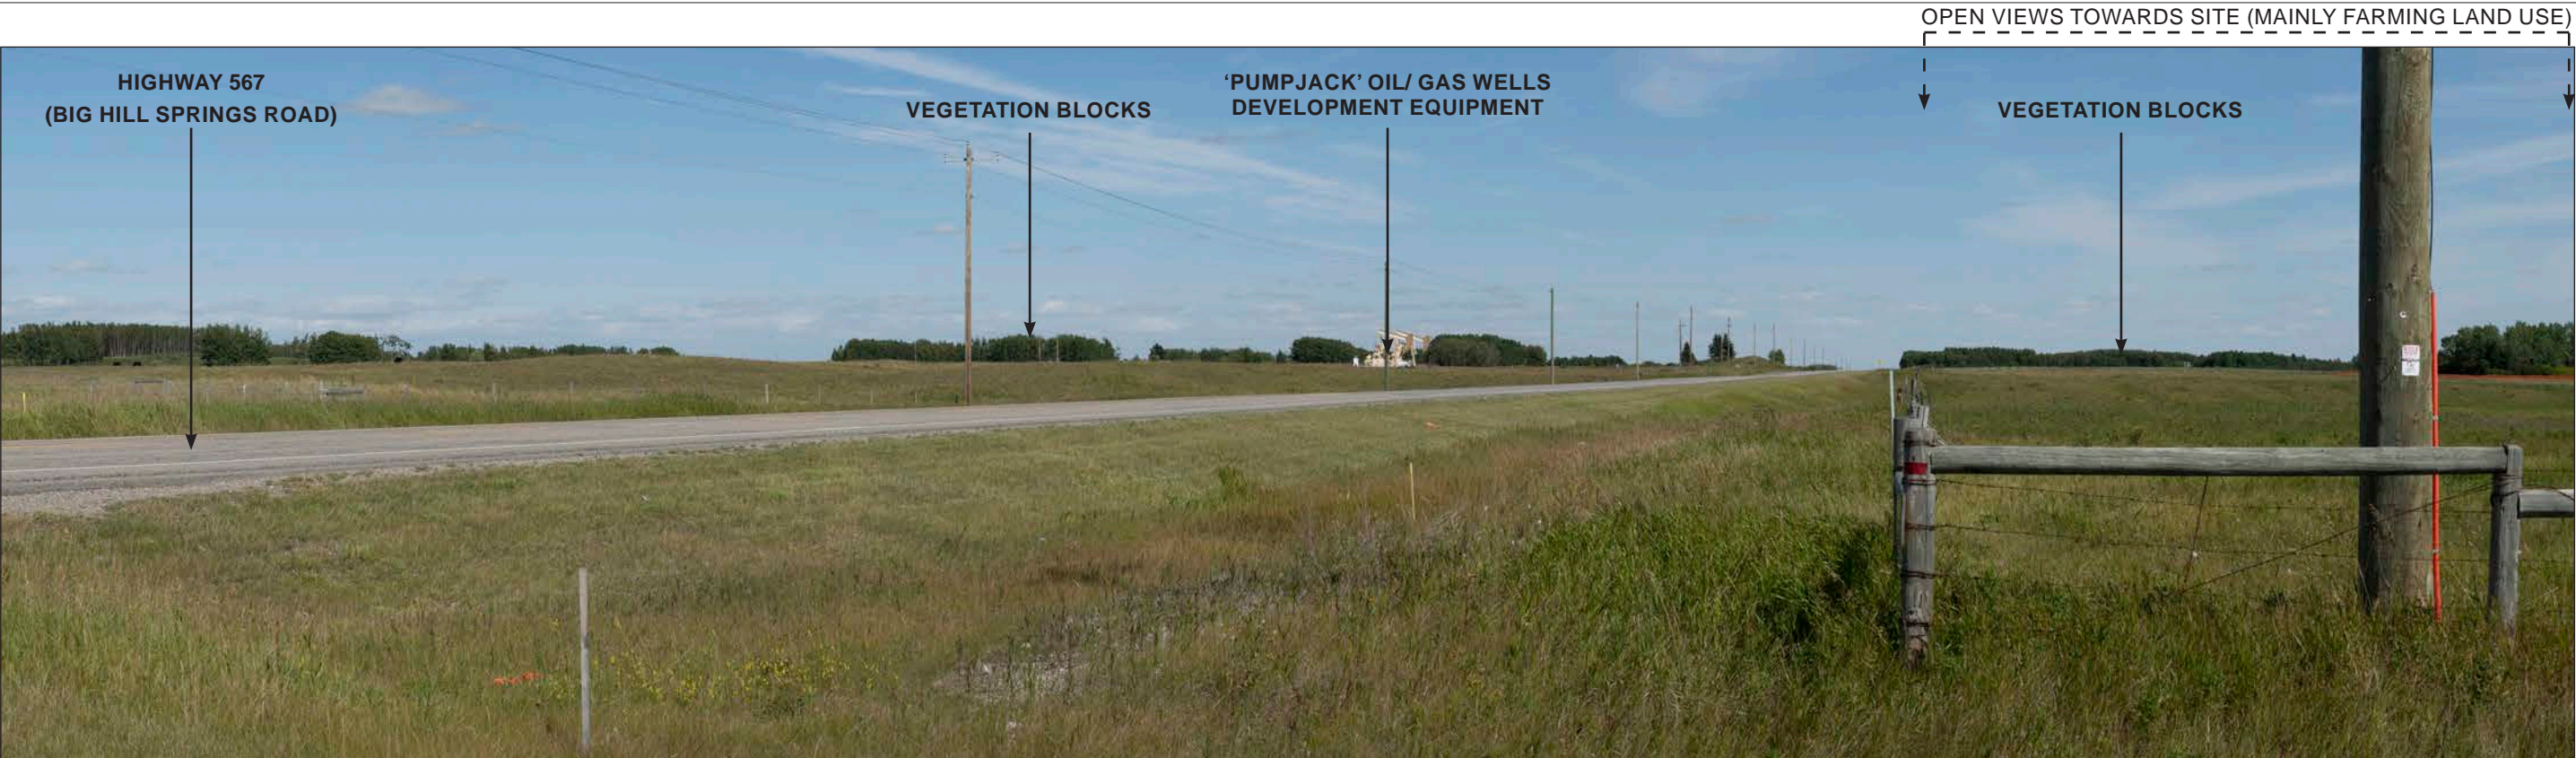
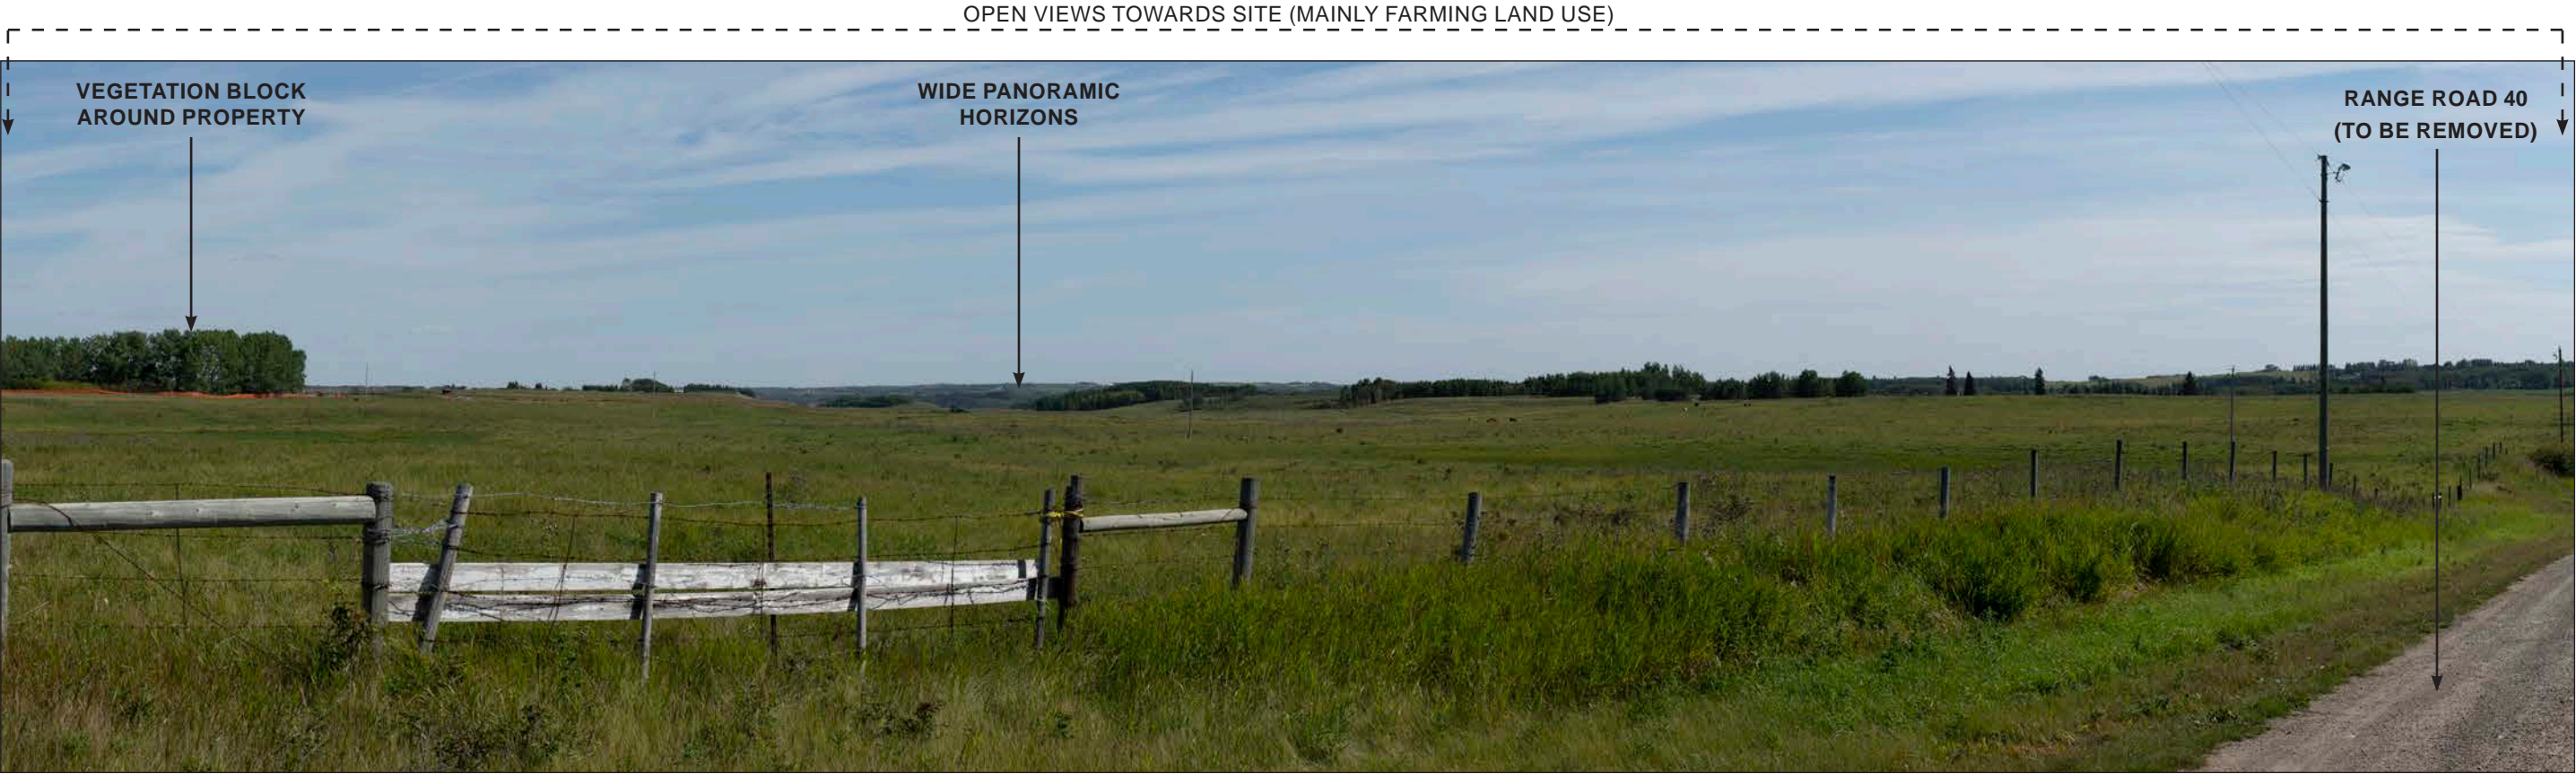
MOUNTAIN ASH	
	VISUAL APPRAISAL	
	DRAWING 3	
Scale AS SHOWN	Date DECEMBER 2019

VIEWPOINT 1: NORTH-EAST CORNER OF SITE BETWEEN HIGHWAY 567 AND RANGE ROAD 40 LOOKING EAST.

VIEWPOINT 1 (CONTINUED): NORTH-EAST CORNER OF SITE BETWEEN HIGHWAY 567 AND RANGE ROAD 40 LOOKING SOUTH-EAST.

OPEN VIEWS TOWARDS SITE (MAINLY FARMING LAND USE)

As shown by Viewpoints 1 and 4, the site slopes gently to the south and southeast from the higher ground to the north-eastern (1,298 masl) and western boundaries (1,294 masl).

As shown by Viewpoints 1 and 4, other physical changes to the immediately surrounding area caused by human activities include Highway 567 to the north, the pumpjack oil/gas wells and the overhead powerlines on wooden poles as well as wooden fencing posts. Although these additional structures detract slightly from the sparsely settled, remote character of the area, their concentration is at a low-level.

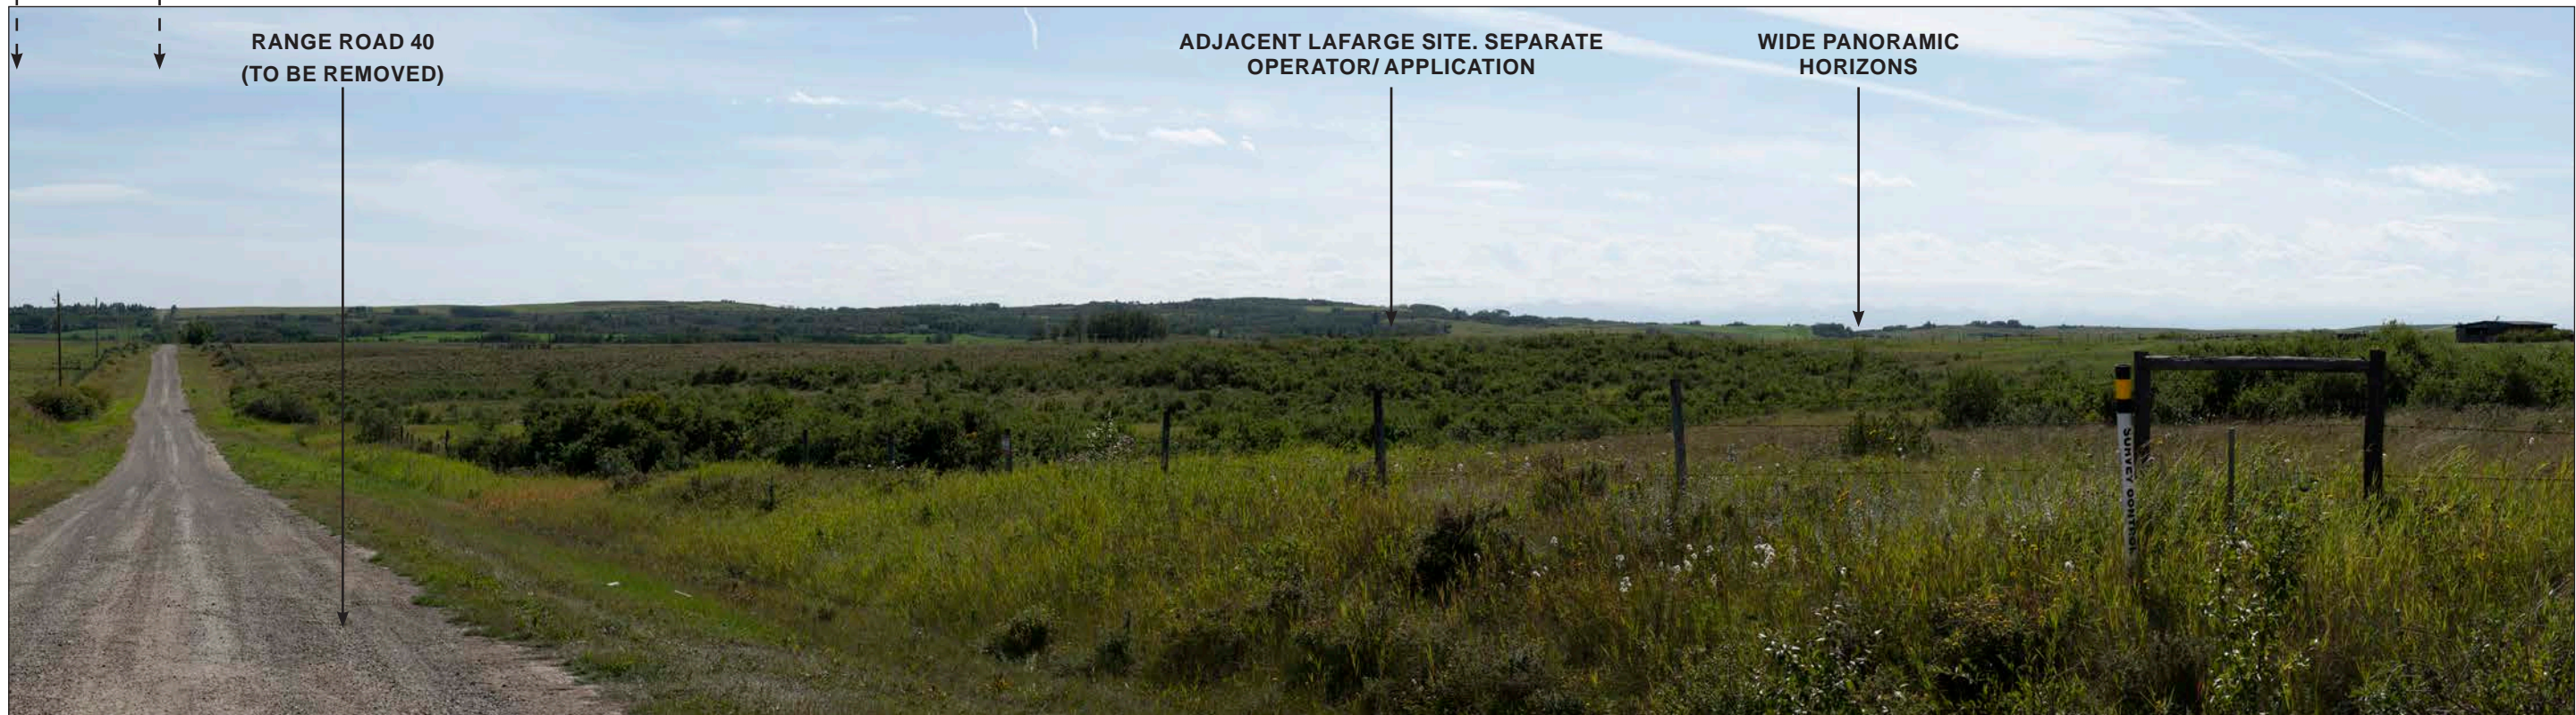
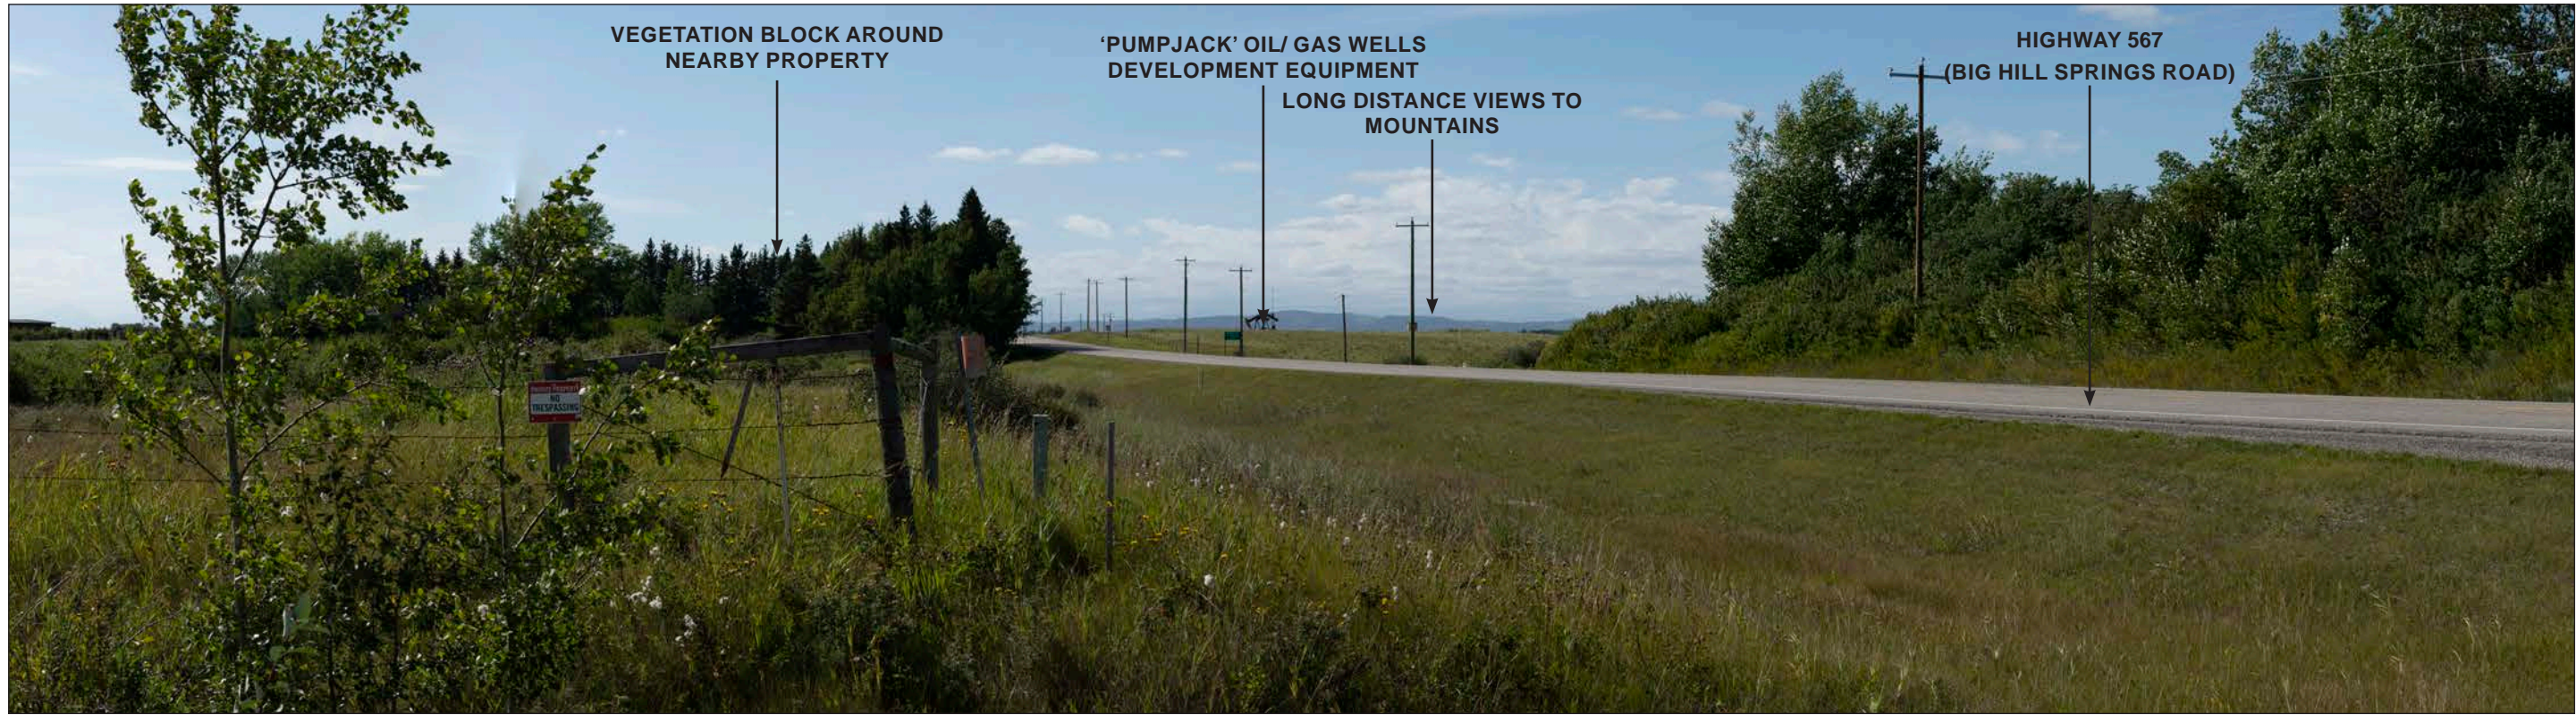
MOUNTAIN ASH	
	VISUAL APPRAISAL	
DRAWING 4		
Scale AS SHOWN	Date DECEMBER 2019

VIEWPOINT 1 (CONTINUED): NORTH-EAST CORNER OF SITE BETWEEN HIGHWAY 567 AND RANGE ROAD 40 LOOKING SOUTH-WEST.

VIEWPOINT 1 (CONTINUED): NORTH-EAST CORNER OF SITE BETWEEN HIGHWAY 567 AND RANGE ROAD 40 LOOKING WEST.

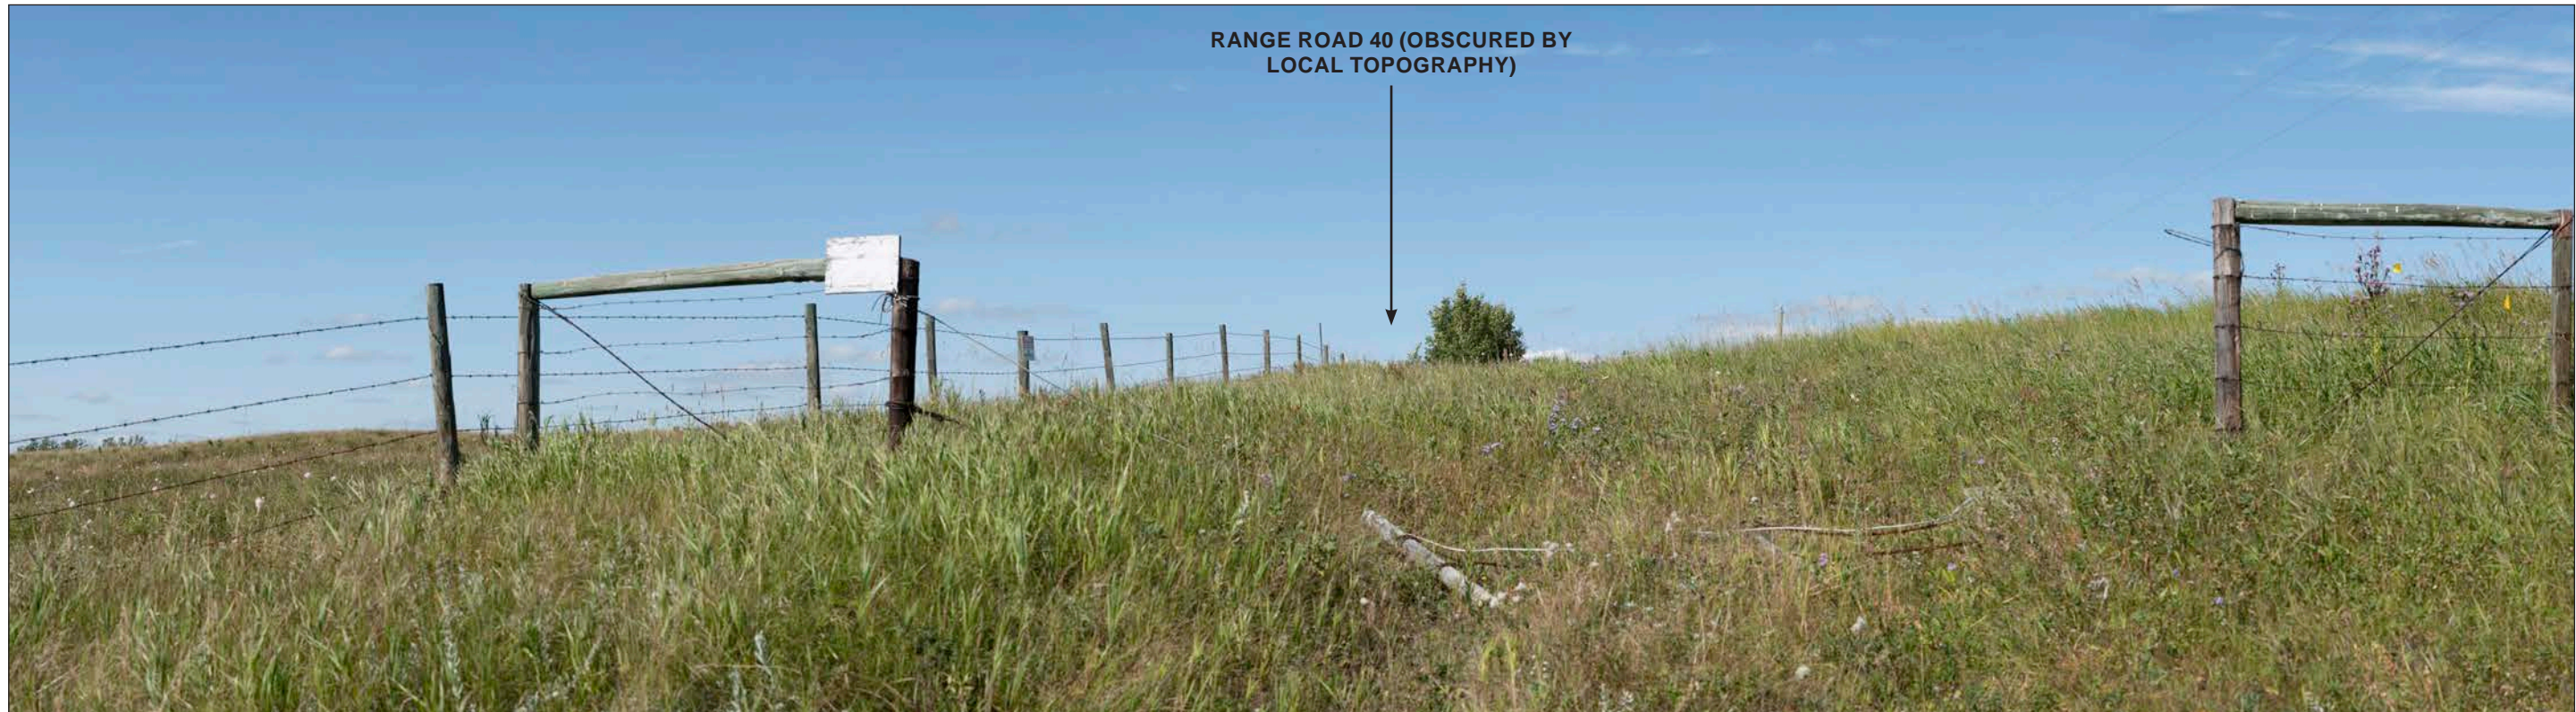
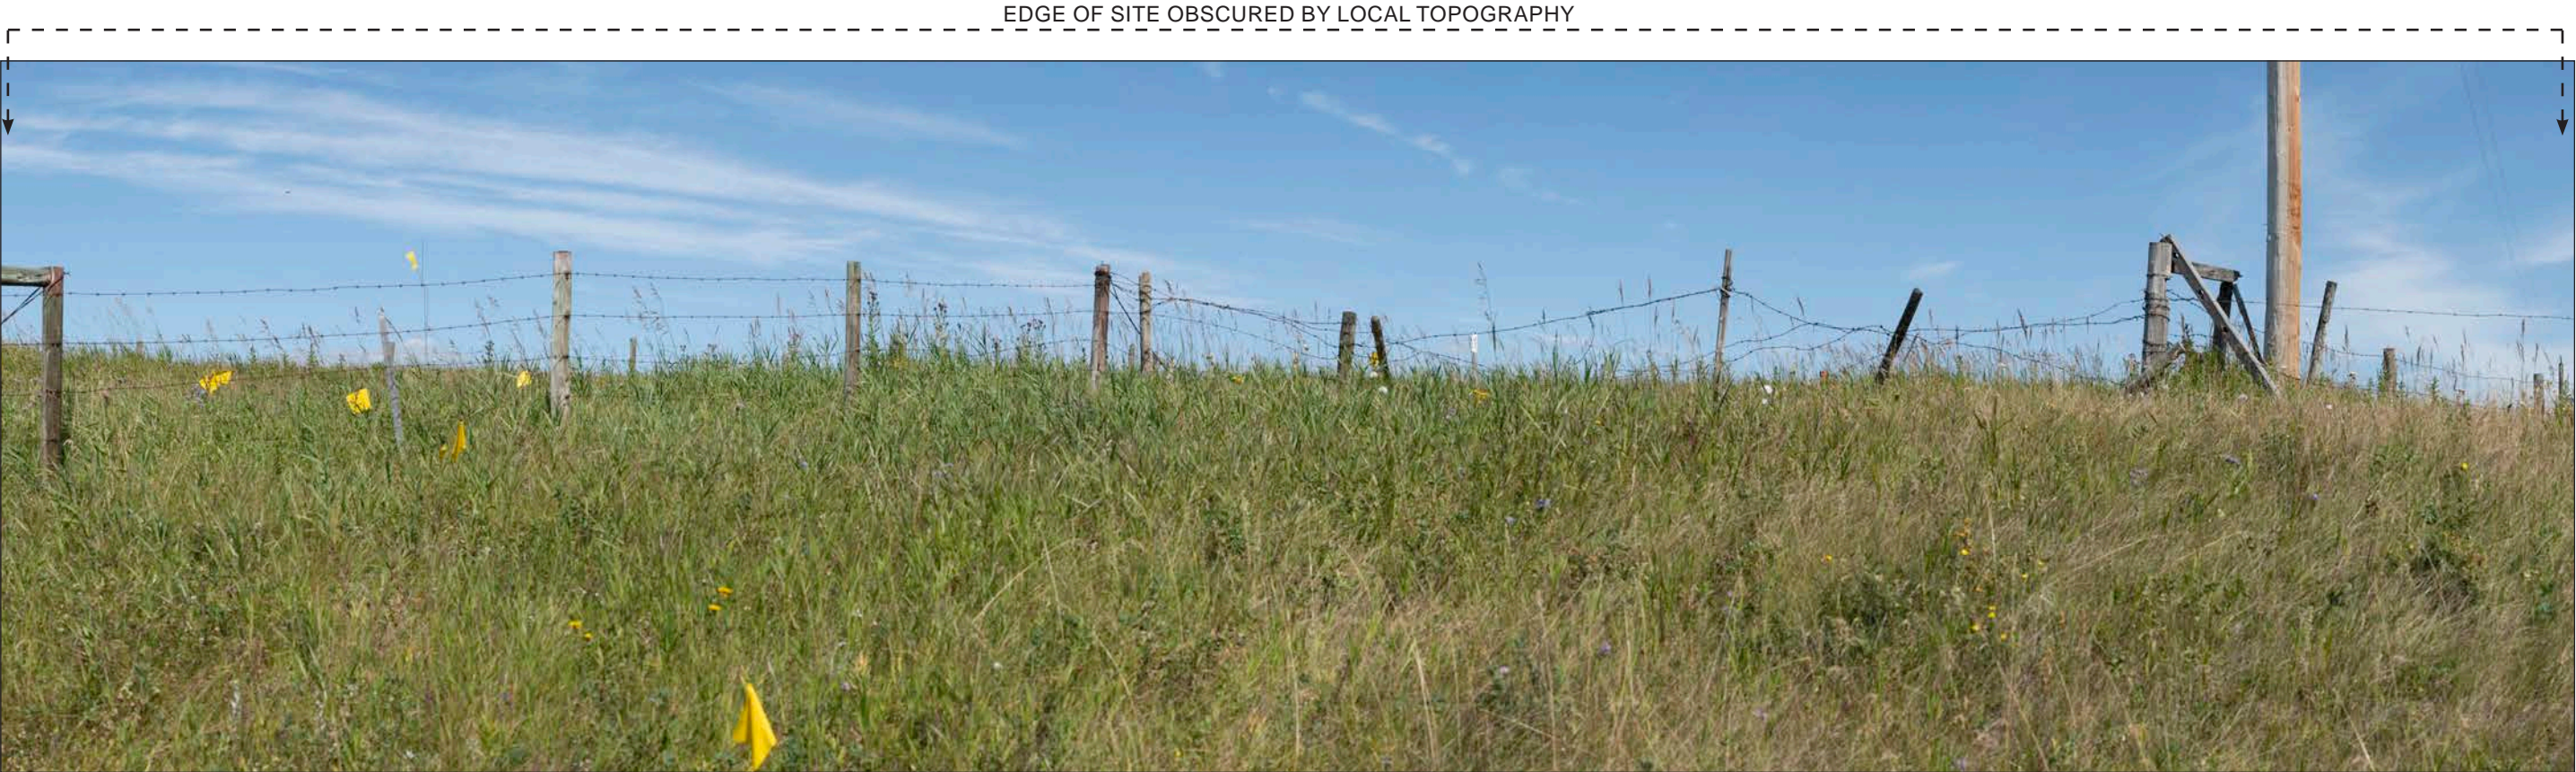
VIEWPOINT 2: AT WESTERN EDGE OF SITE, NEAR RANGE ROAD 40 LOOKING NORTH.

VIEWPOINT 2 (CONTINUED): AT WESTERN EDGE OF SITE, NEAR RANGE ROAD 40 LOOKING NORTH-EAST.

EDGE OF SITE OBSCURED BY LOCAL TOPOGRAPHY

EDGE OF LOWER LYING RIPARIAN
AREA/ VALLEY

As shown by Viewpoint 2 and 6, south of the site boundary is a broader c350m wide low-relief valley feature also sloping northwest to southeast and the two valley features converge approximately 700 m south-east of the site.

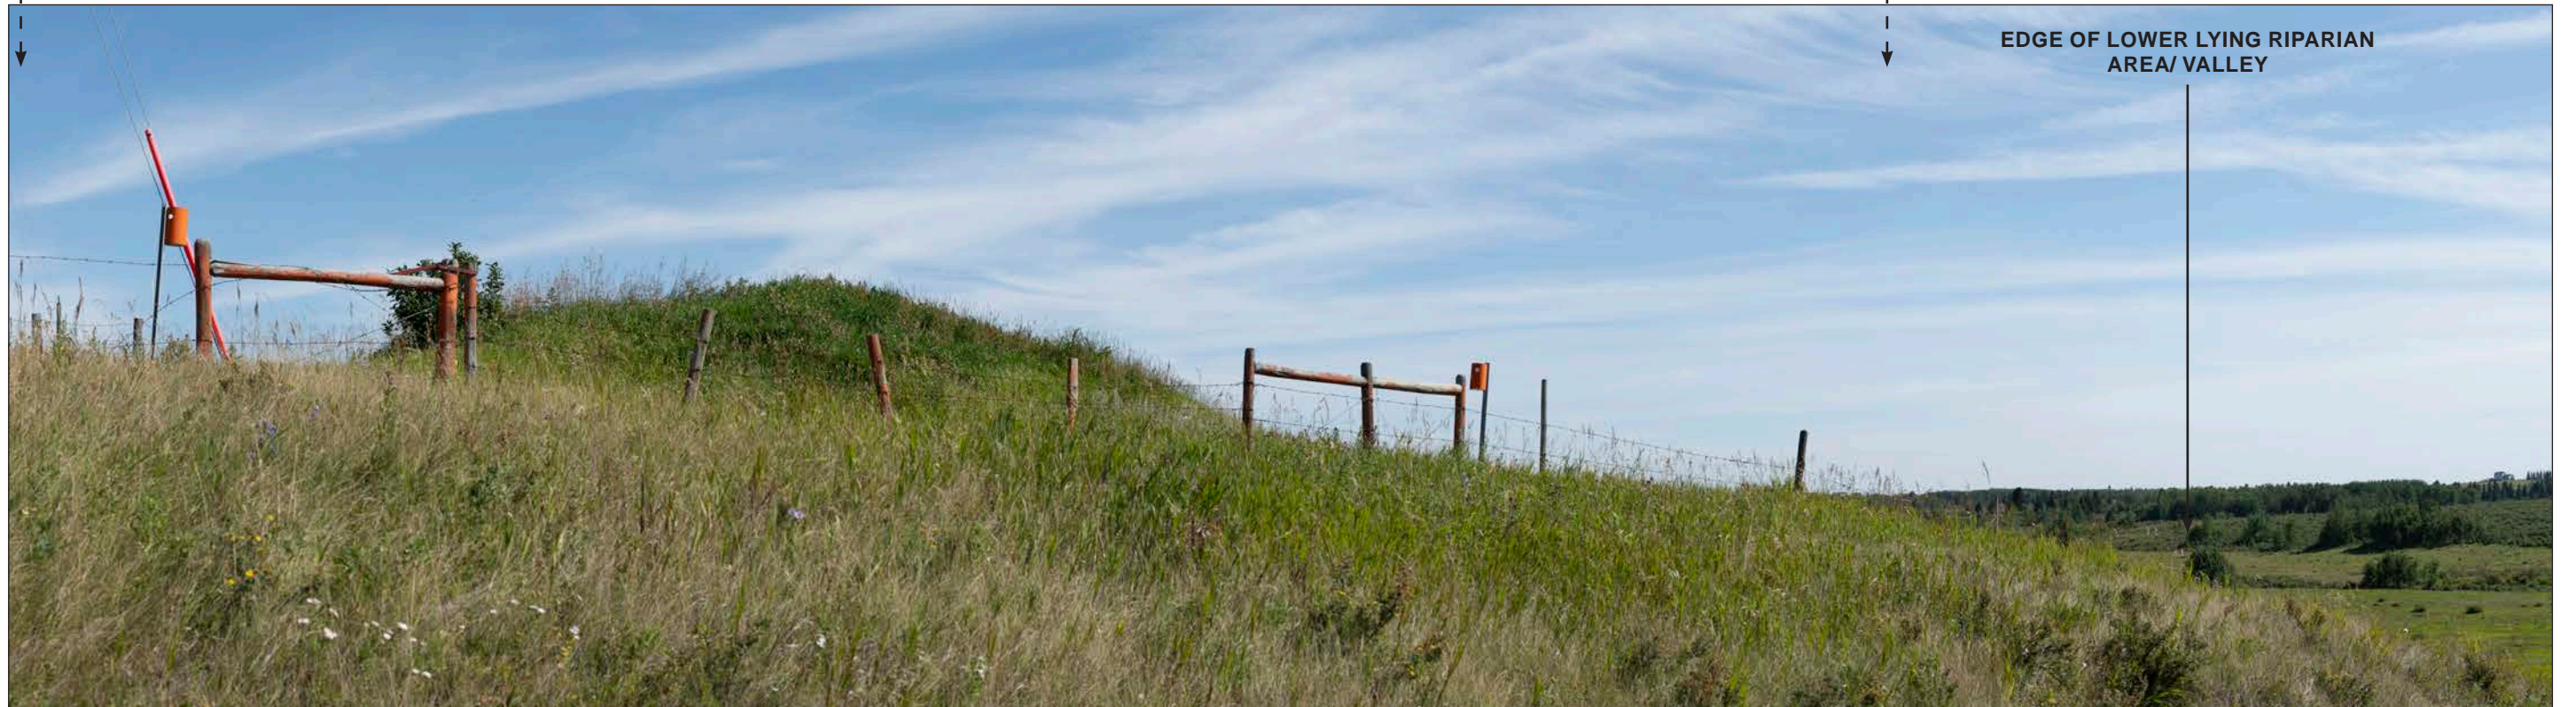
VIEWPOINT 2 (CONTINUED): AT WESTERN EDGE OF SITE, NEAR RANGE ROAD 40 LOOKING SOUTH-EAST.

WIDE PANORAMIC
HORIZONS

BROAD VALLEY TO THE SOUTH-
WEST OF SITE

TREE BELT

VIEWPOINT 2 (CONTINUED): AT WESTERN EDGE OF SITE, NEAR RANGE ROAD 40 LOOKING SOUTH.

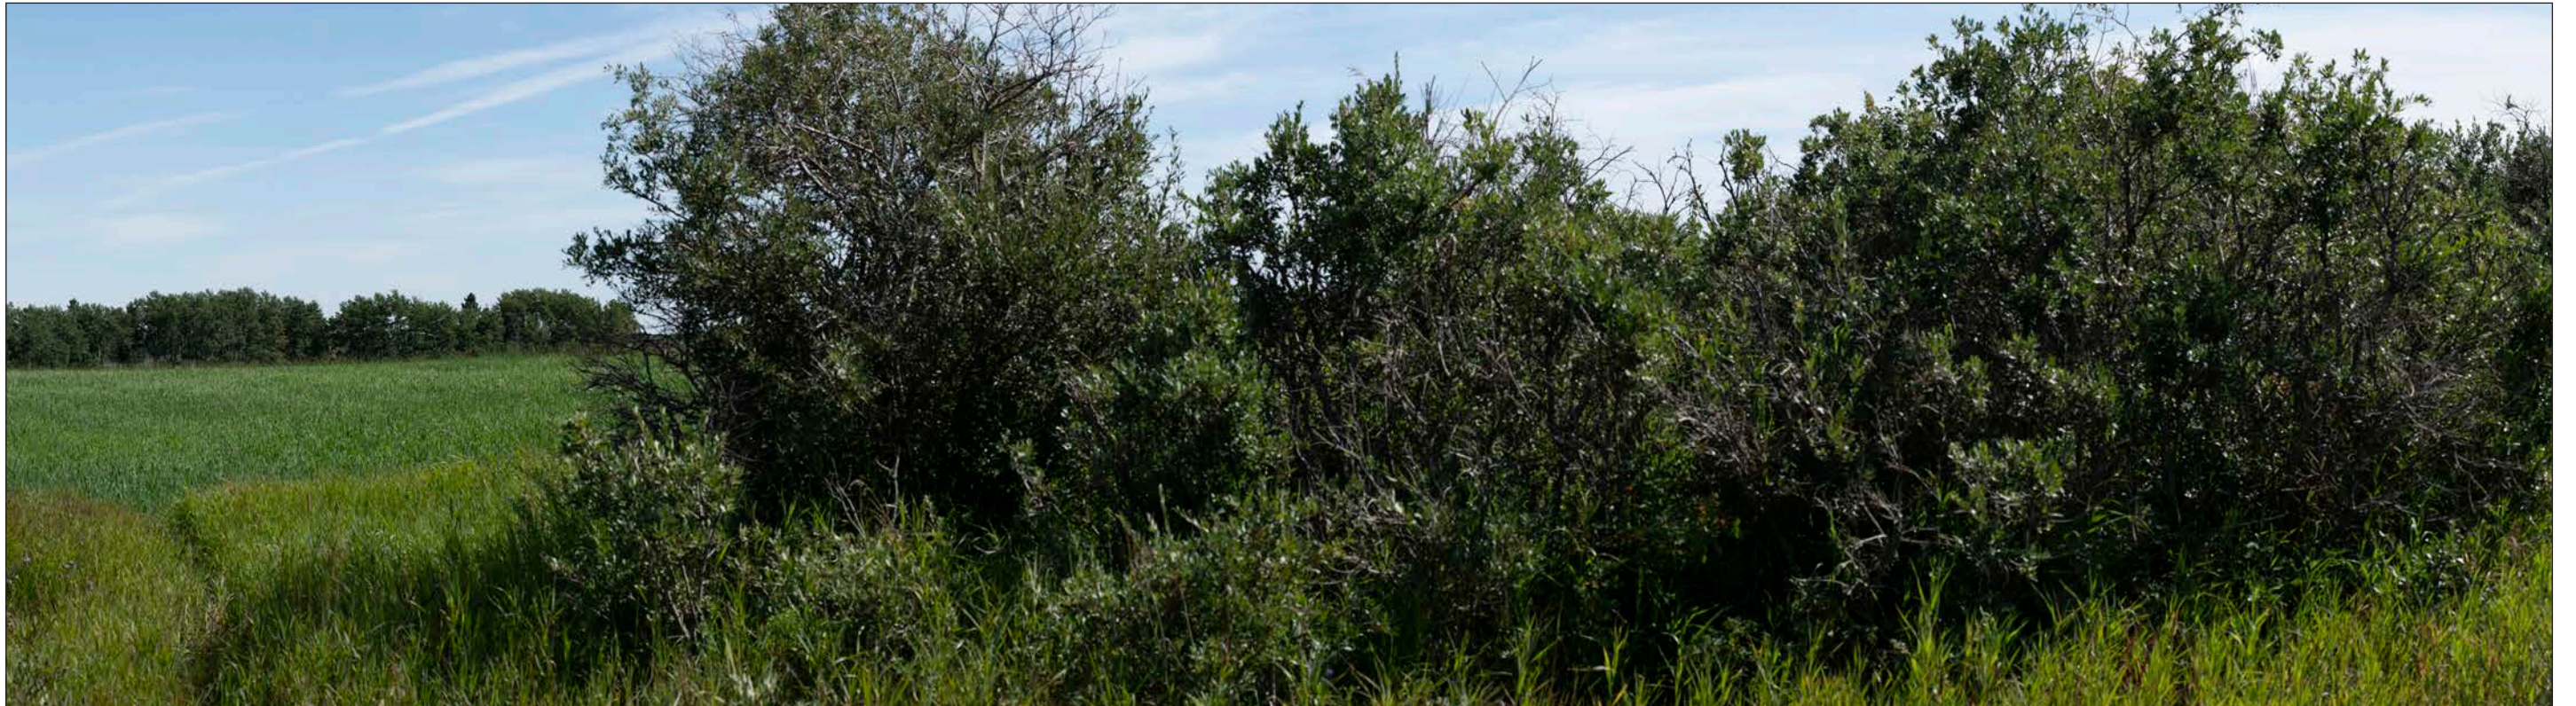
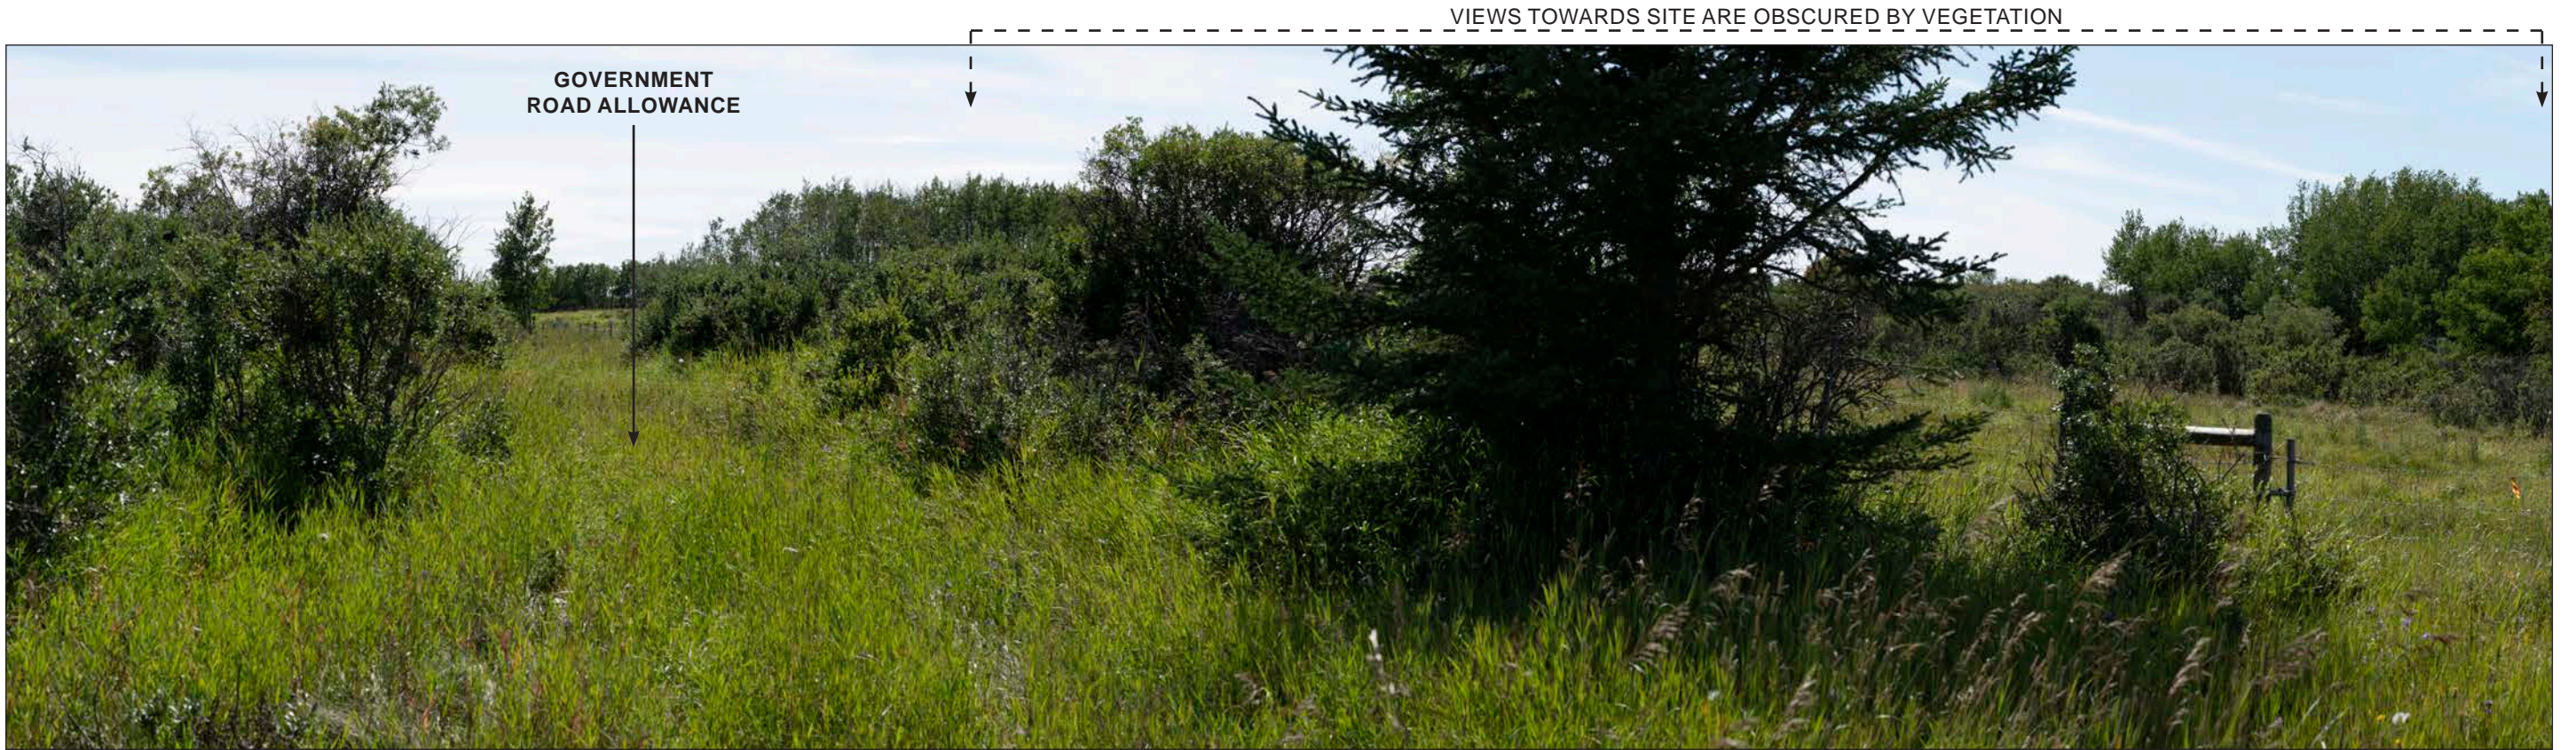
VIEWPOINT 3: AT SOUTH-WESTERN CORNER OF SITE ON GOVERNMENT ROAD ALLOWANCE LOOKING NORTH-WEST.

VIEWPOINT 3 (CONTINUED): AT SOUTH-WESTERN CORNER OF SITE ON GOVERNMENT ROAD ALLOWANCE LOOKING NORTH.

VIEWS TOWARDS SITE ARE OBSCURED BY VEGETATION
