**Mountain Ash Limited Partnership Aggregate Operation
NW and SW 31-26-03 W5M, Rocky View County, Alberta**

Visual Appraisal

**February 2020
SLR Project No.: 212.06650.00003/008**

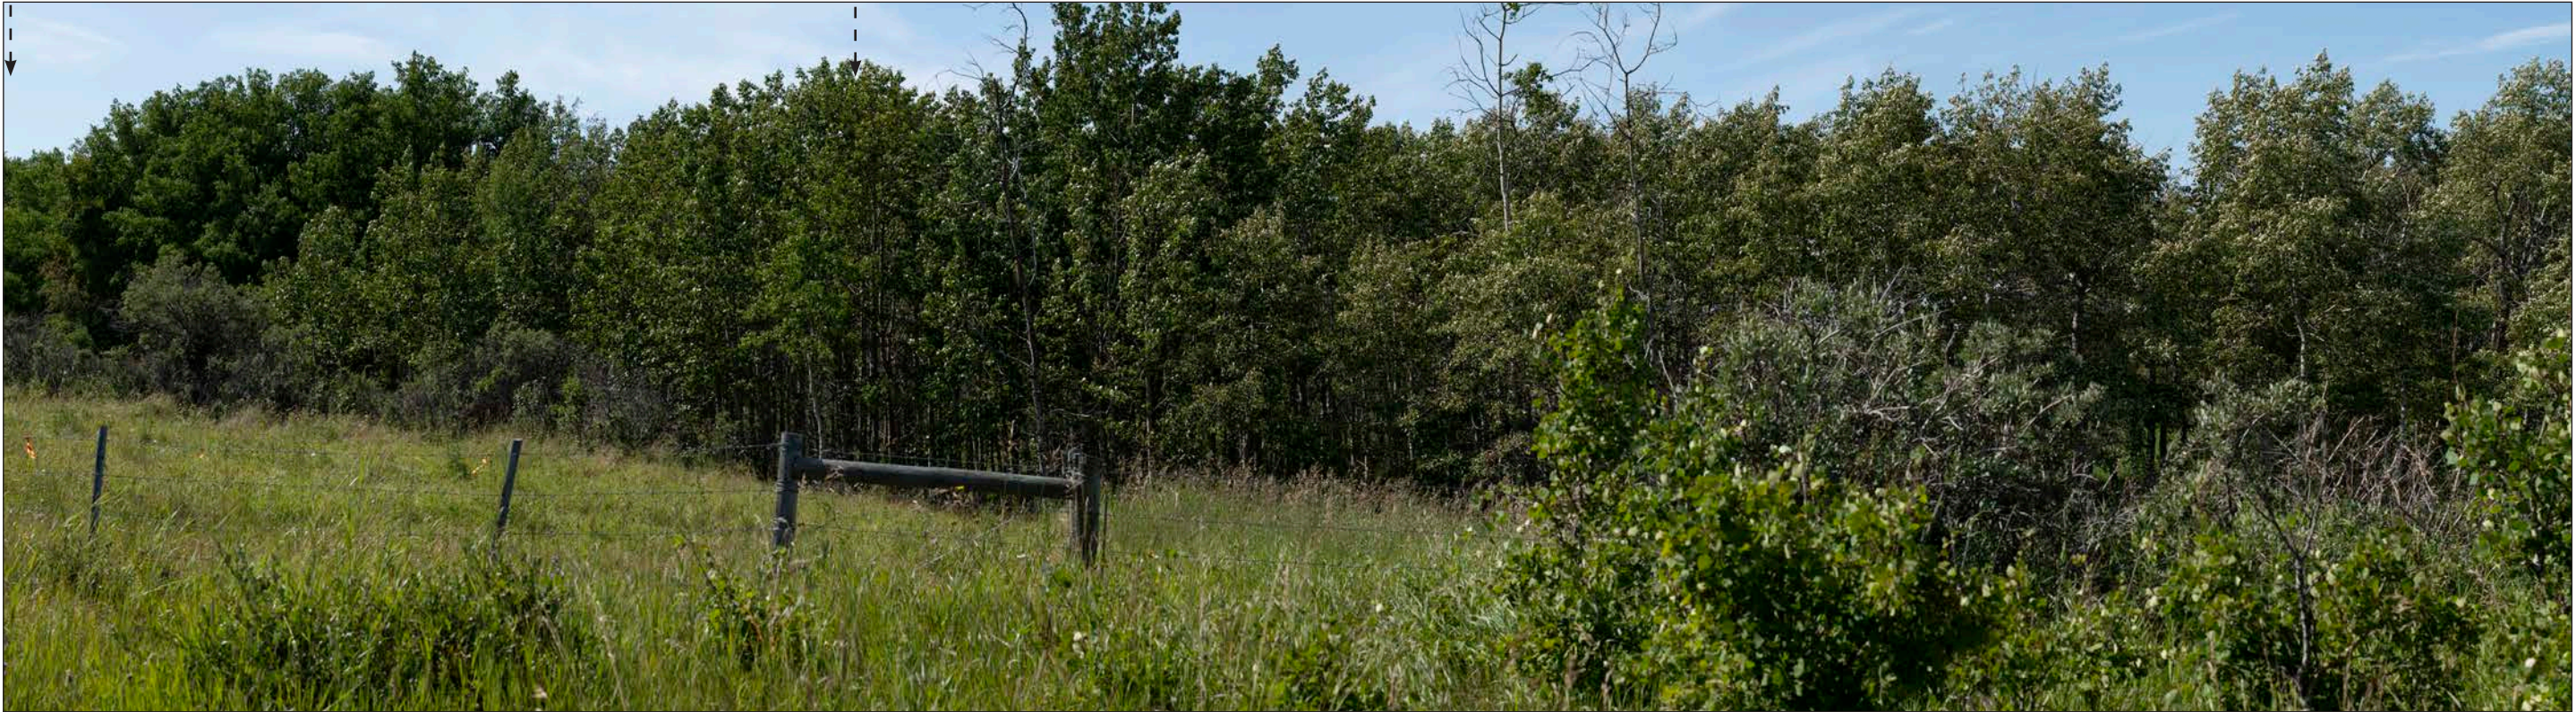
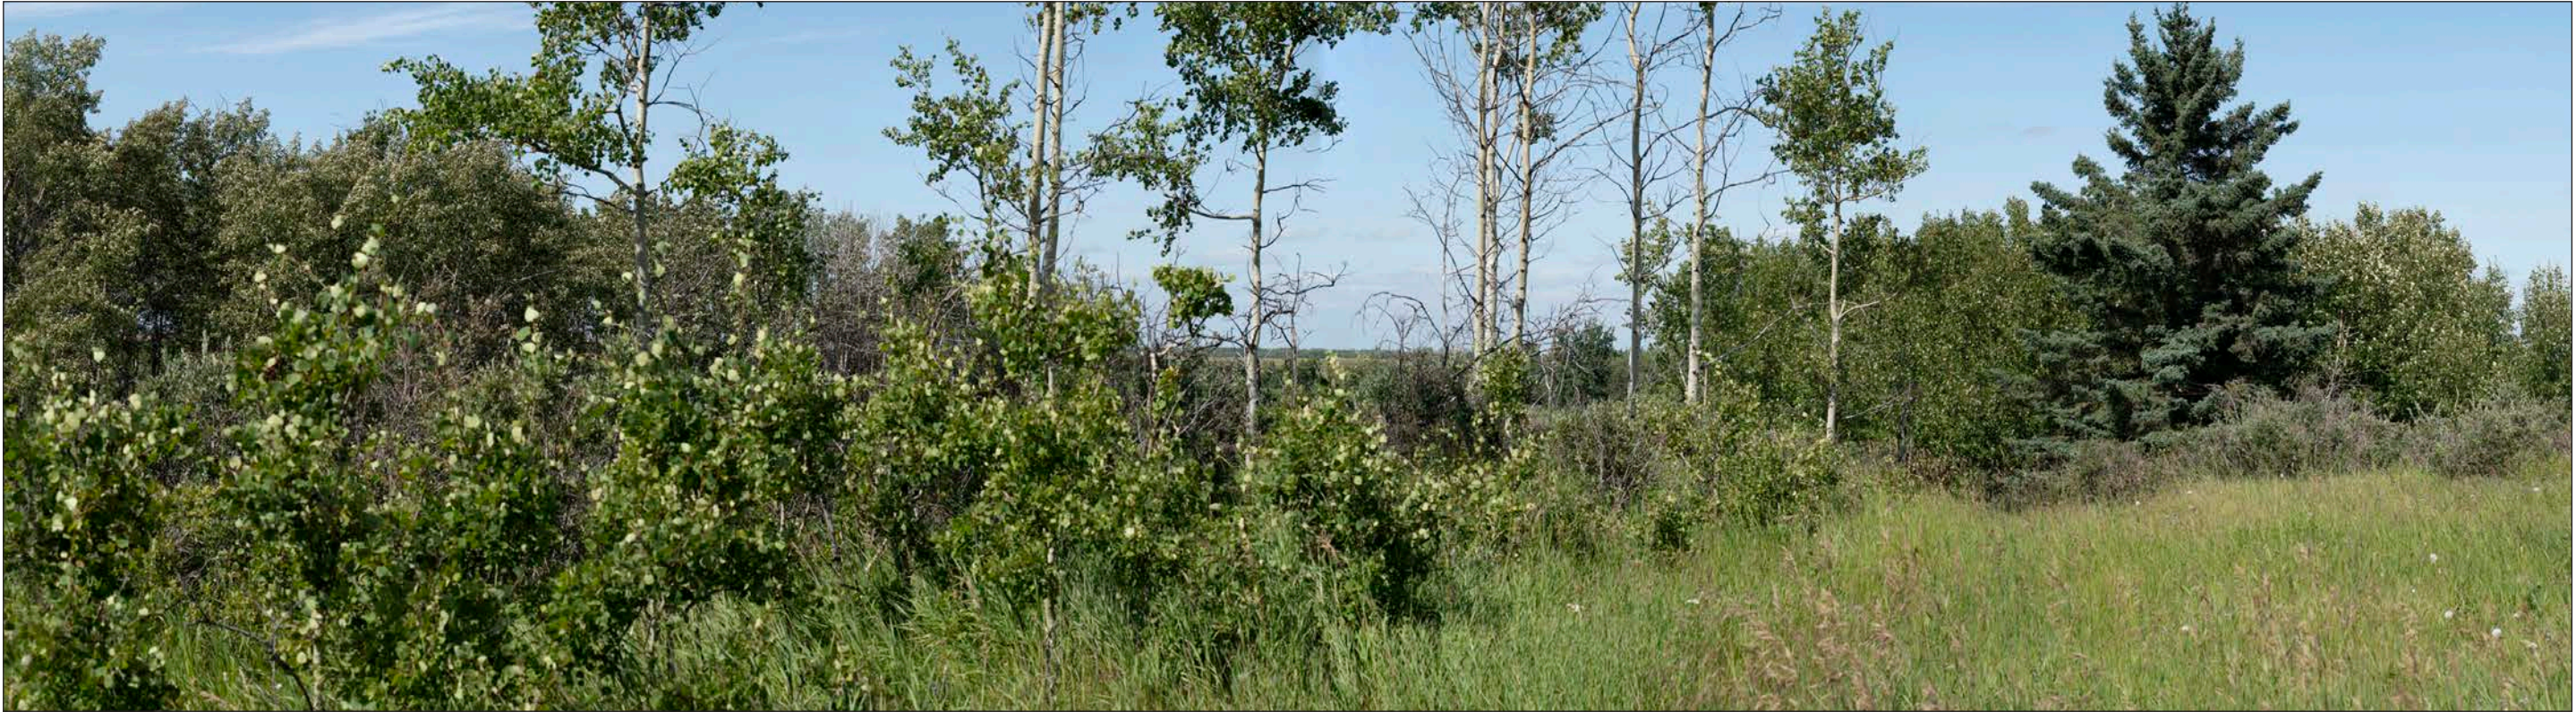
DRAWING 8	
	Scale AS SHOWN	Date DECEMBER 2019

VIEWPOINT 3 (CONTINUED): AT SOUTH-WESTERN CORNER OF SITE ON GOVERNMENT ROAD ALLOWANCE LOOKING NORTH-EAST.

VIEWPOINT 3 (CONTINUED): AT SOUTH-WESTERN CORNER OF SITE ON GOVERNMENT ROAD ALLOWANCE LOOKING EAST.

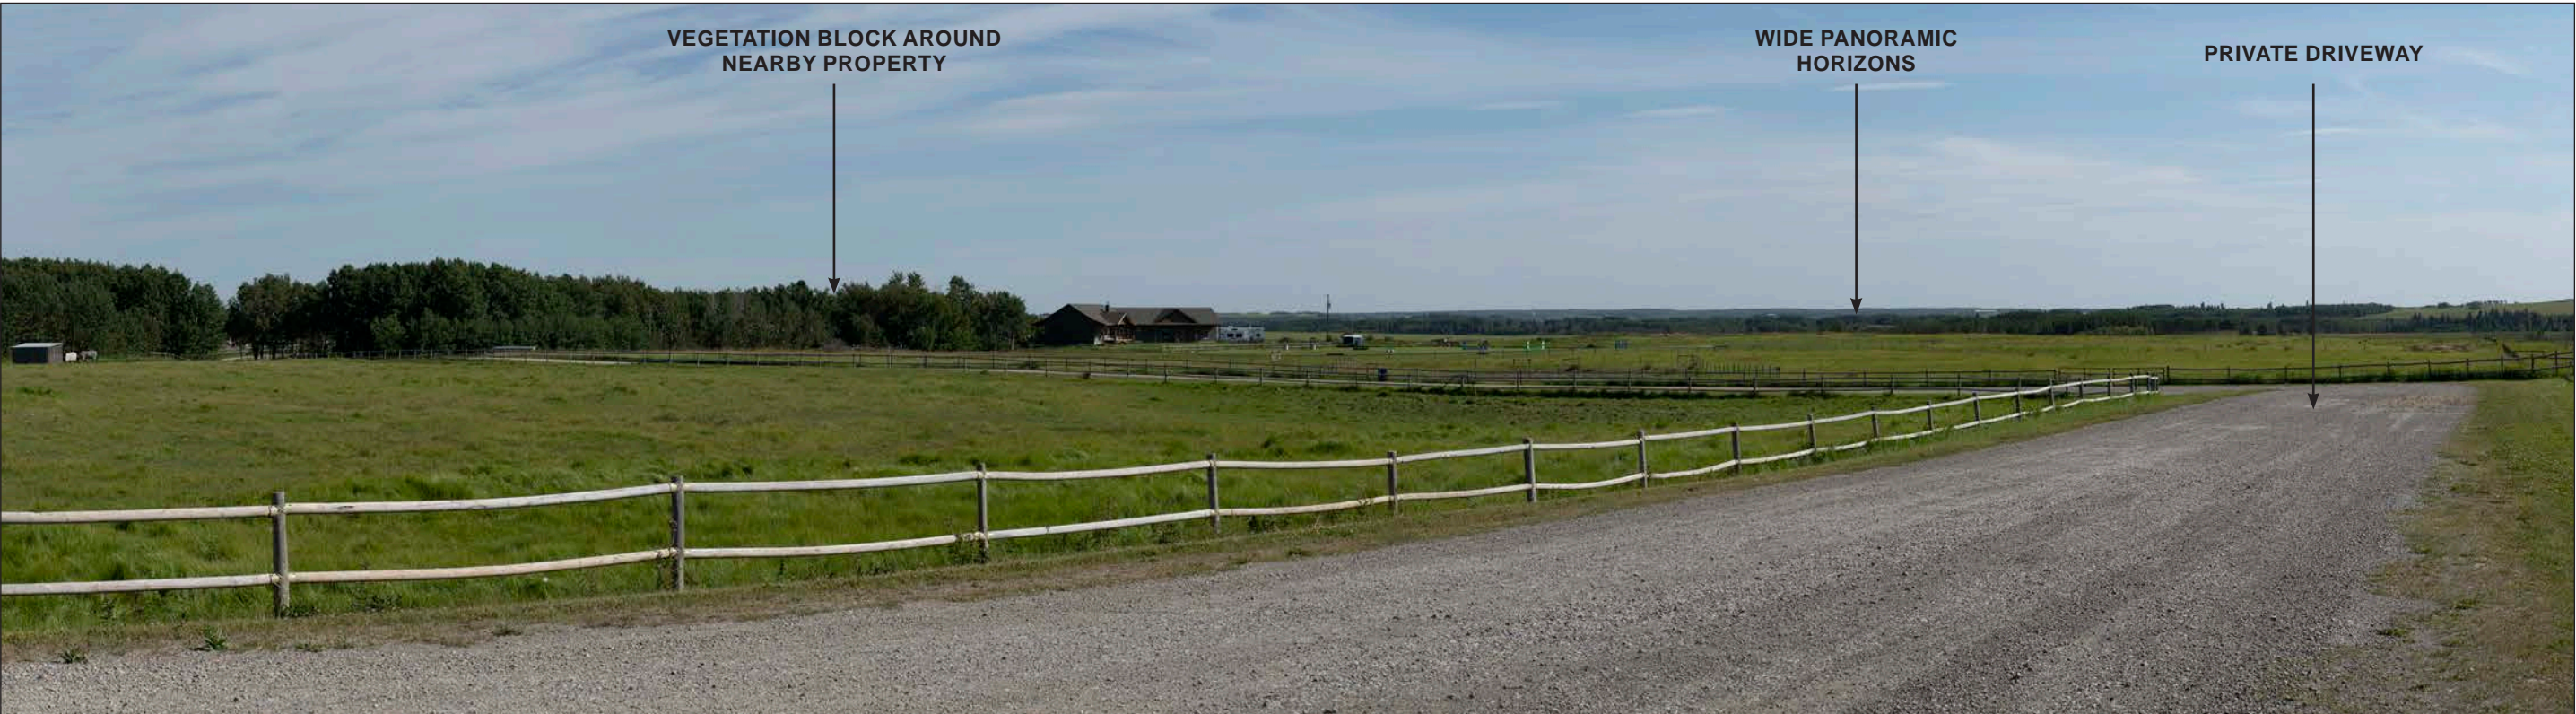
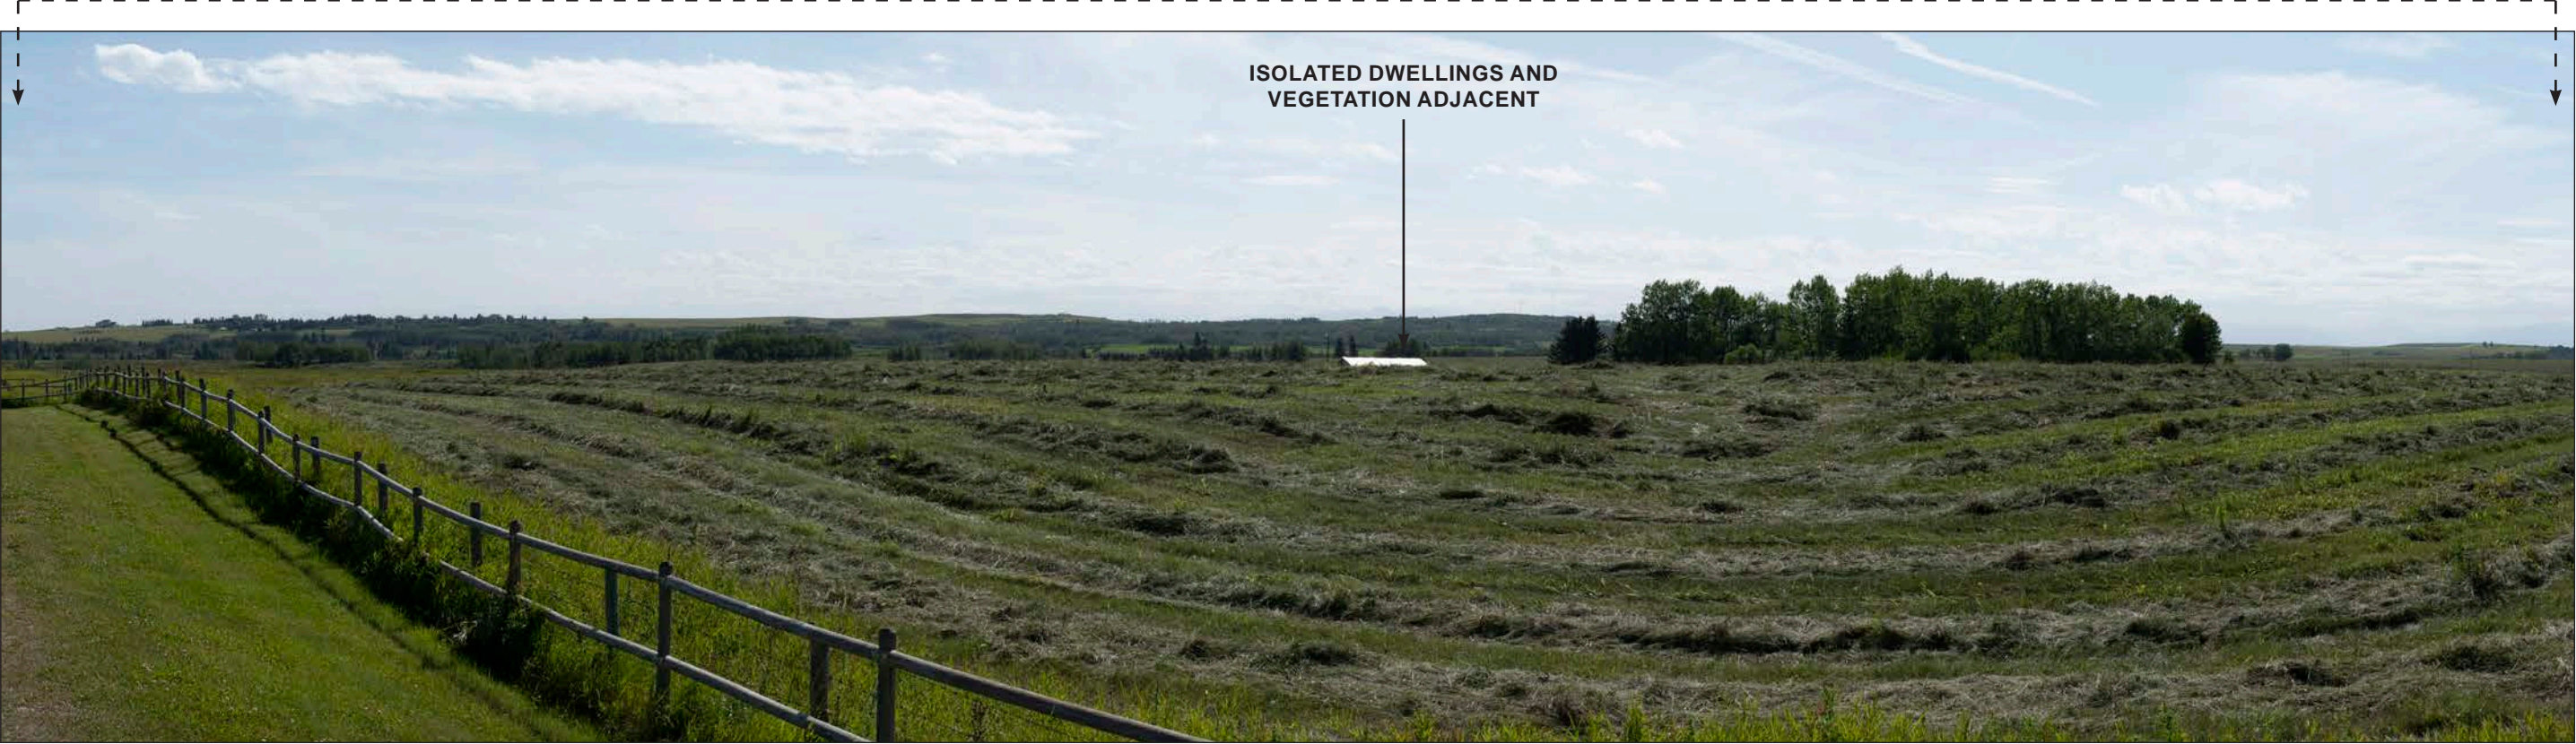
MOUNTAIN ASH	
	VISUAL APPRAISAL	
DRAWING 9		
Scale AS SHOWN	Date DECEMBER 2019

VIEWPOINT 4: NORTH-EAST CORNER OF SITE BETWEEN HIGHWAY 567 AND GRAVEL ROAD LOOKING SOUTH.
OPEN VIEWS TOWARDS SITE (MAINLY FARMING LANDUSE)

VIEWPOINT 4 (CONTINUED): NORTH-EAST CORNER OF SITE BETWEEN HIGHWAY 567 AND GRAVEL ROAD LOOKING SOUTH-WEST.

As shown by Viewpoints 1 and 4, the site slopes gently to the south and southeast from the higher ground to the north-eastern (1,298 masl) and western boundaries (1,294 masl).

Several of the residences on site contain non-native vegetation and it has been noted that tree belts around properties are also characteristic of the wider area, for example as shown by Viewpoint 4.

As shown by Viewpoints 1 and 4, other physical changes to the immediately surrounding area caused by human activities include Highway 567 to the north, the pumpjack oil/gas wells and the overhead powerlines on wooden poles as well as wooden fencing posts. Although these additional structures detract slightly from the sparsely settled, remote character of the area, their concentration is at a low-level.

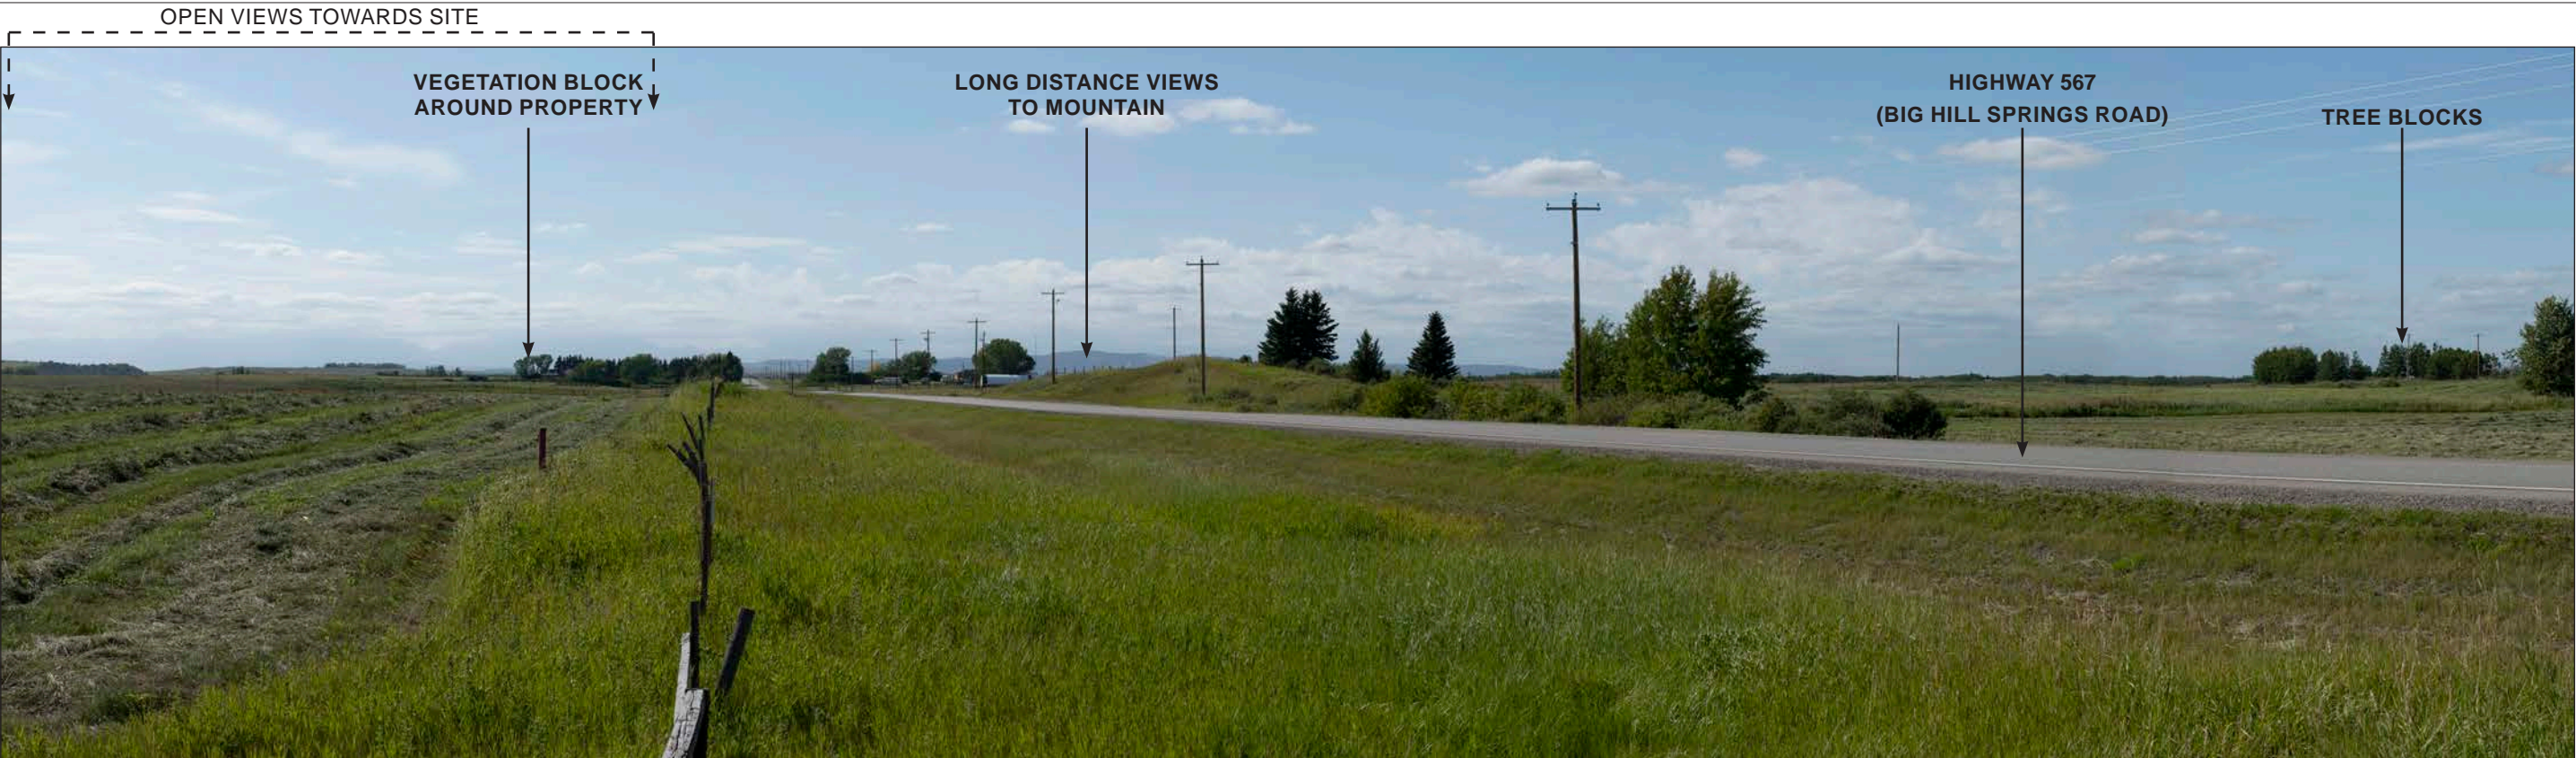
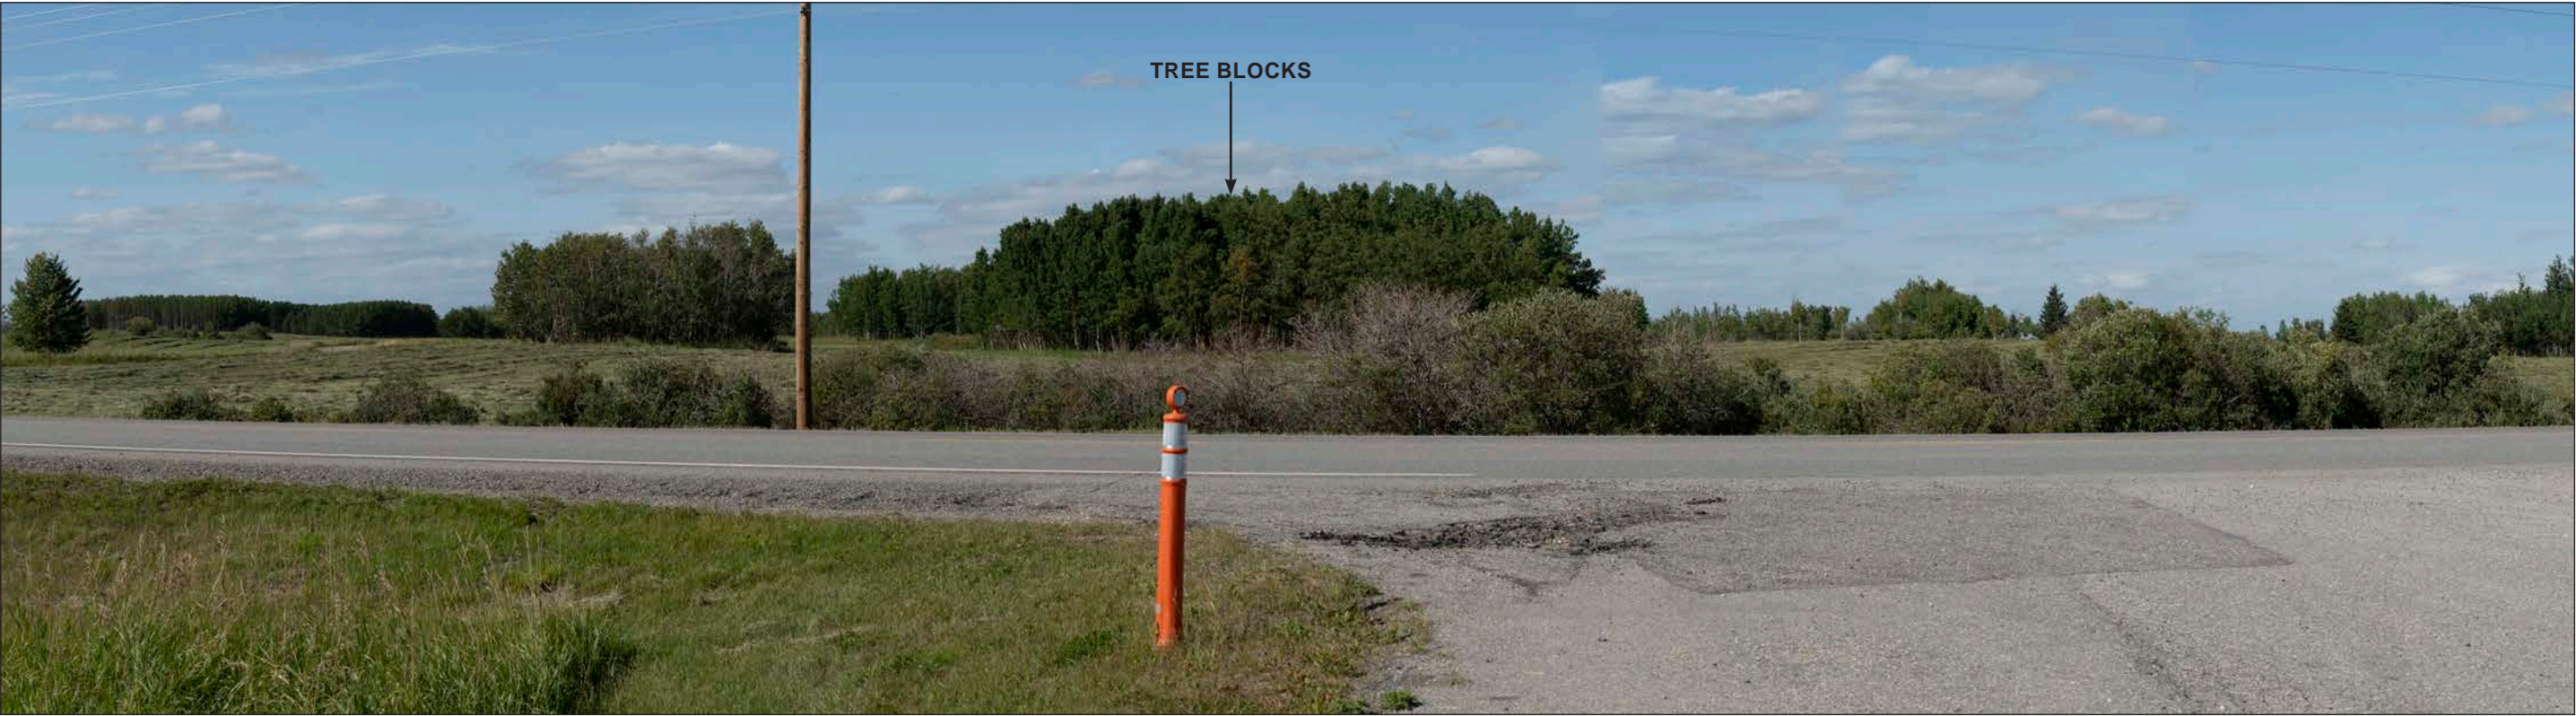
MOUNTAIN ASH	
	VISUAL APPRAISAL	
	DRAWING 10	
Scale AS SHOWN	Date DECEMBER 2019

VIEWPOINT 4 (CONTINUED): NORTH-EAST CORNER OF SITE BETWEEN HIGHWAY 567 AND GRAVEL ROAD LOOKING WEST.

VIEWPOINT 4 (CONTINUED): NORTH-EAST CORNER OF SITE BETWEEN HIGHWAY 567 AND GRAVEL ROAD LOOKING NORTH-WEST.

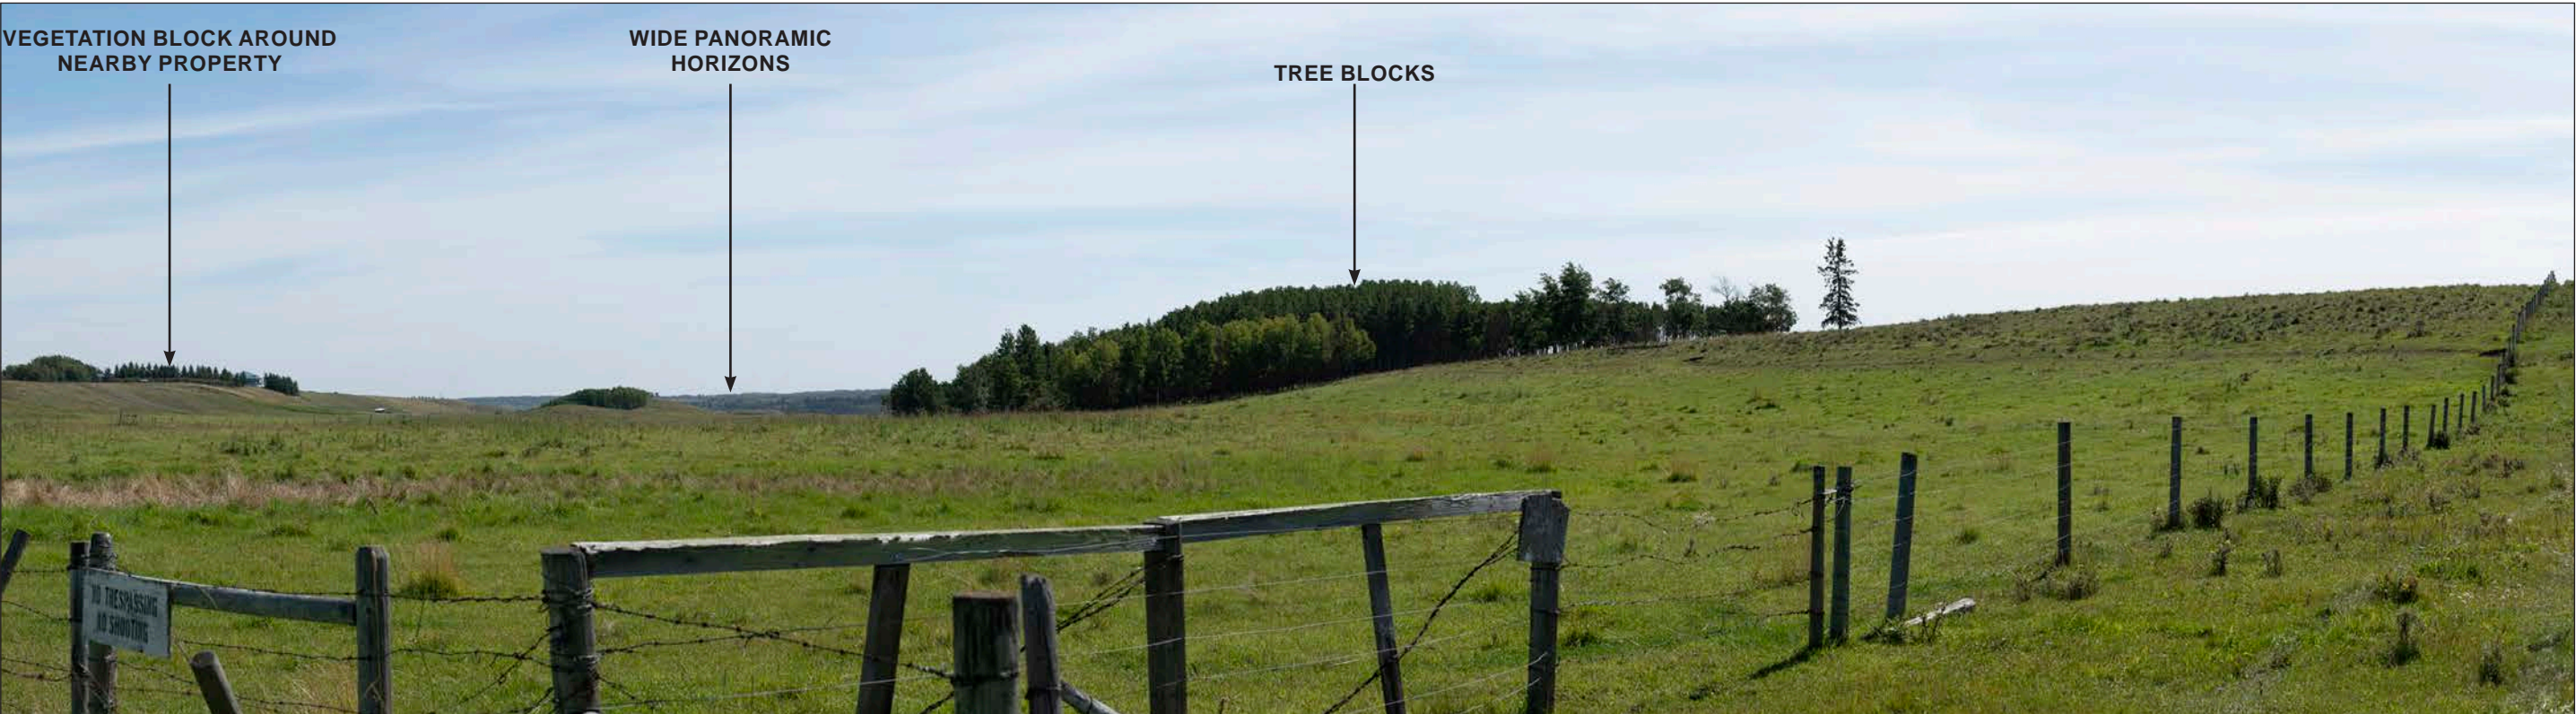
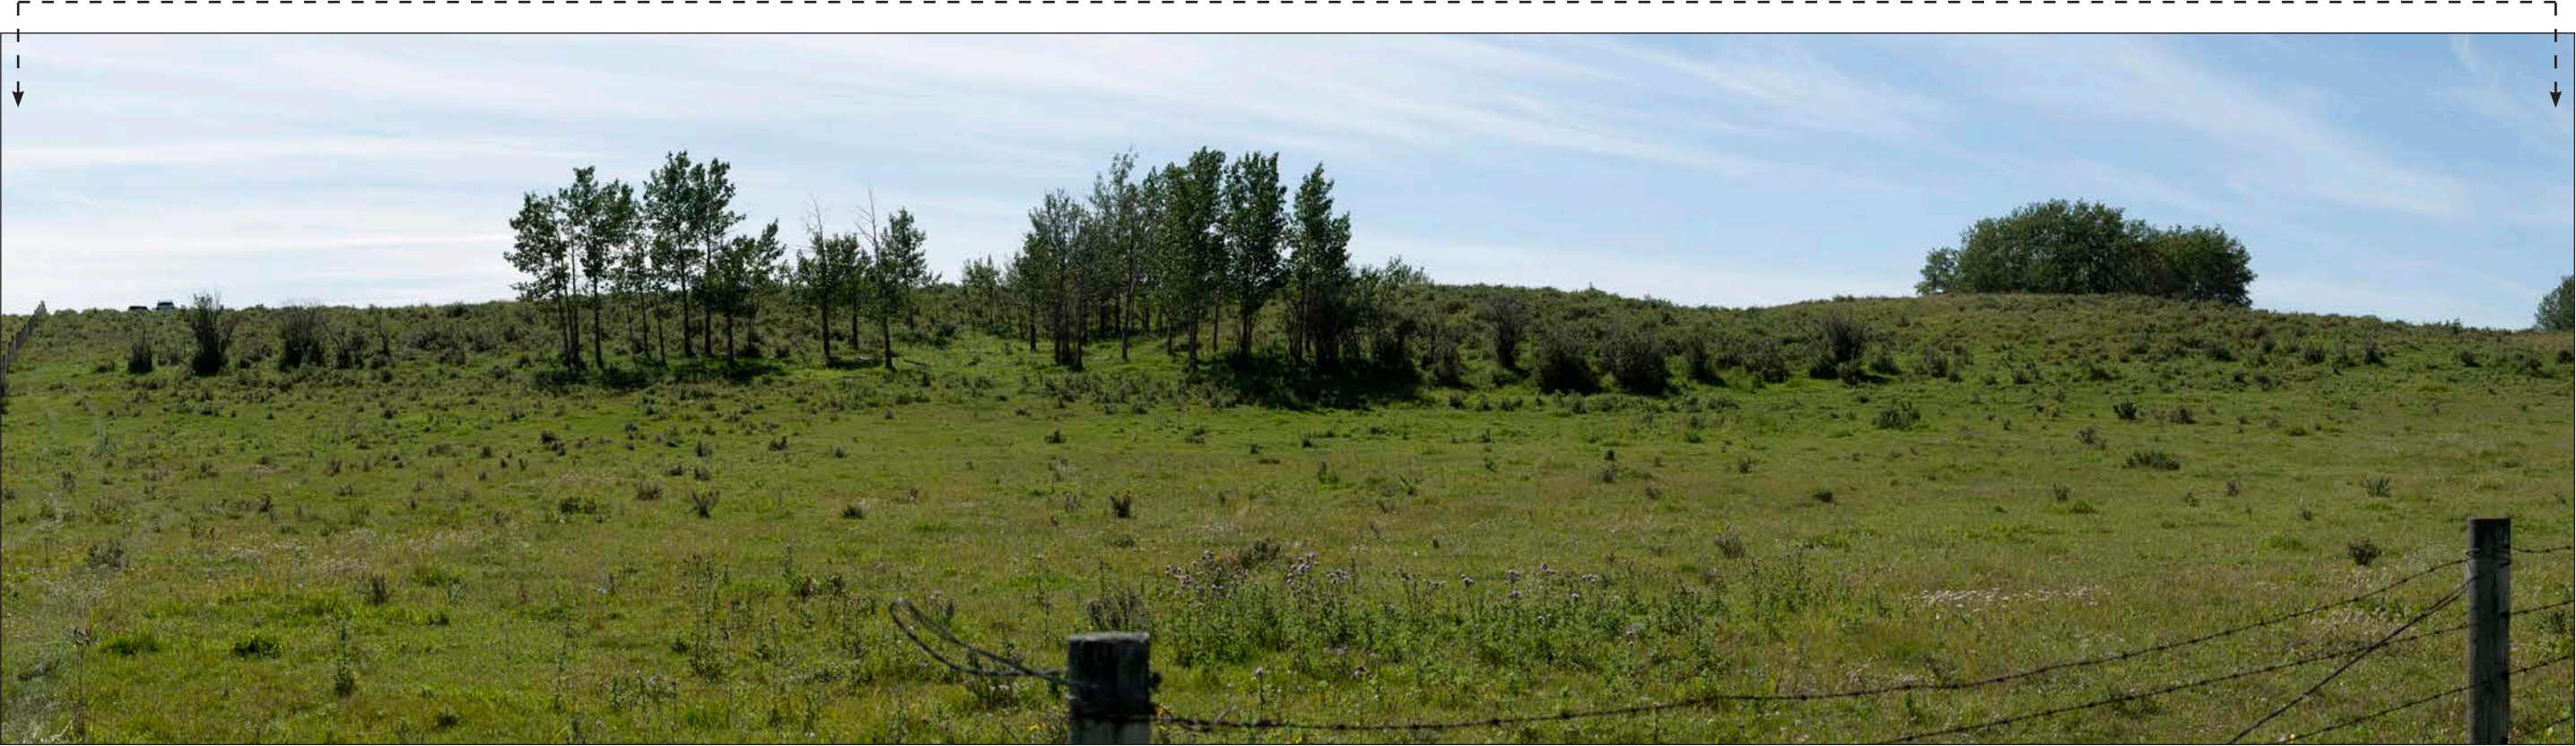
MOUNTAIN ASH	
	VISUAL APPRAISAL	
DRAWING 11		
Scale AS SHOWN	Date DECEMBER 2019

VIEWPOINT 5: AT EASTERN EDGE OF SITE, LOOKING SOUTH.

OPEN VIEWS TOWARDS SITE (MAINLY FARMING LANDUSE)

VIEWPOINT 5 (CONTINUED): AT EASTERN EDGE OF SITE, LOOKING SOUTH-WEST.

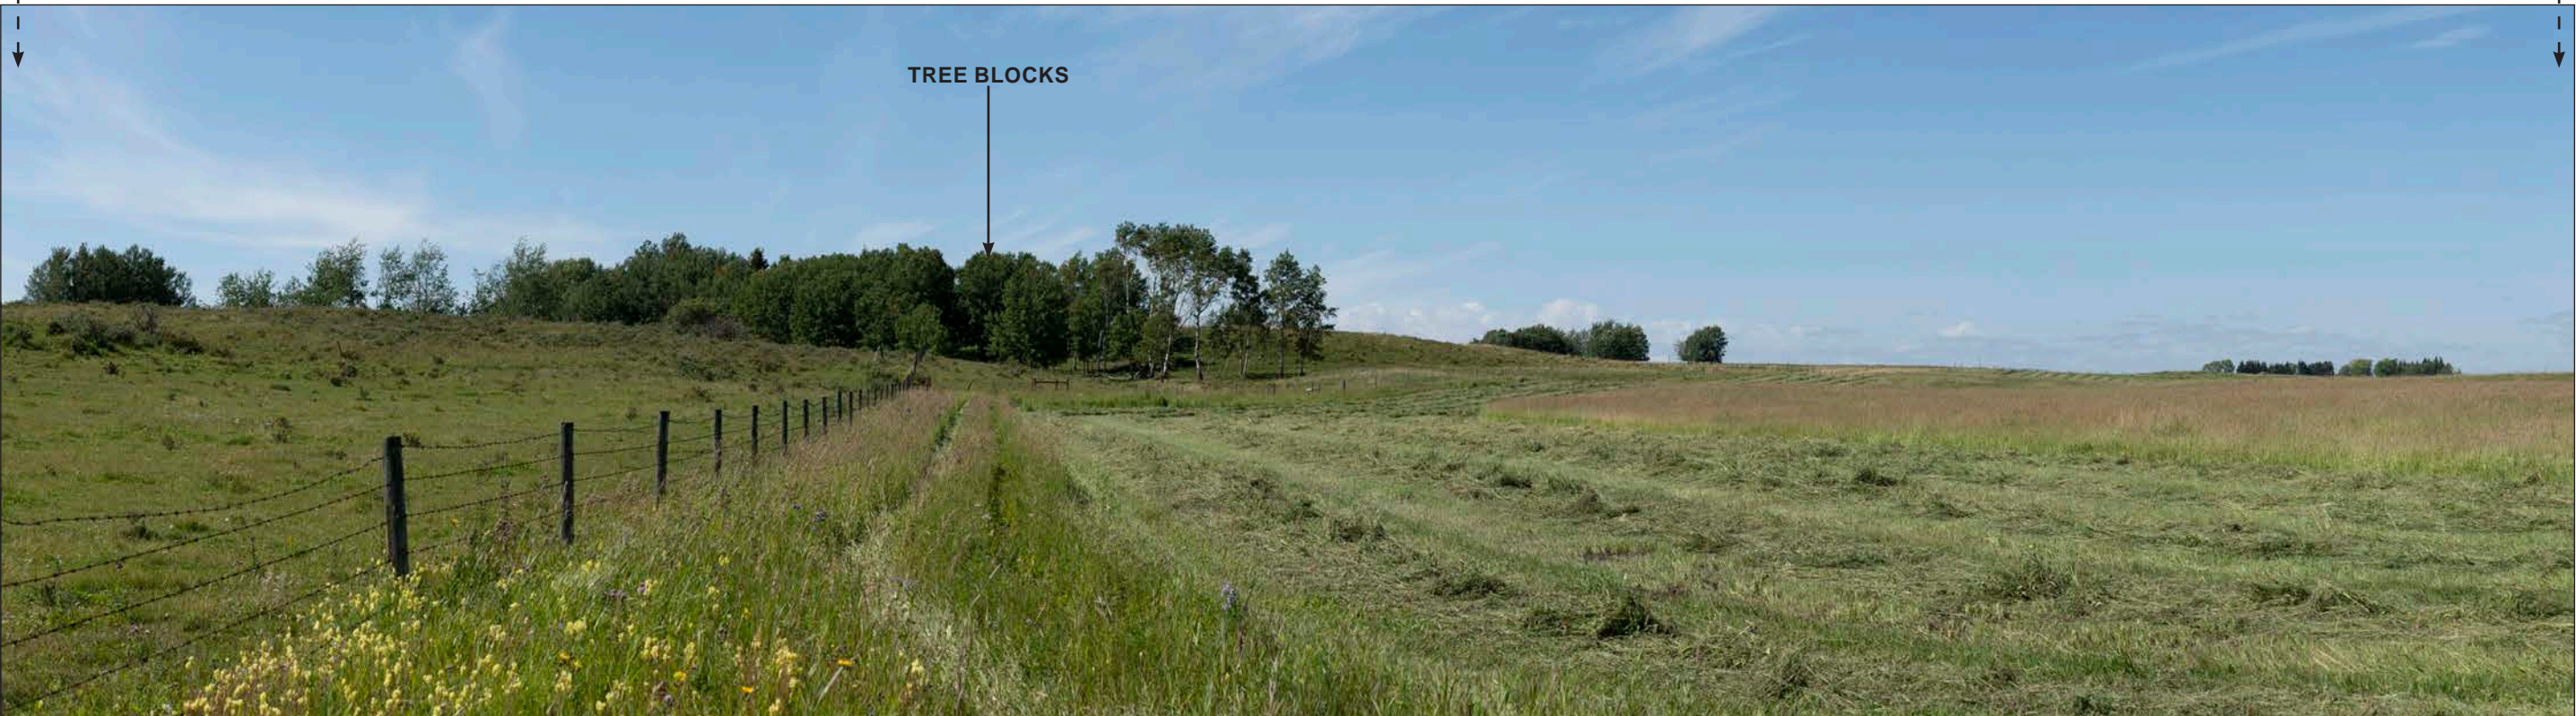
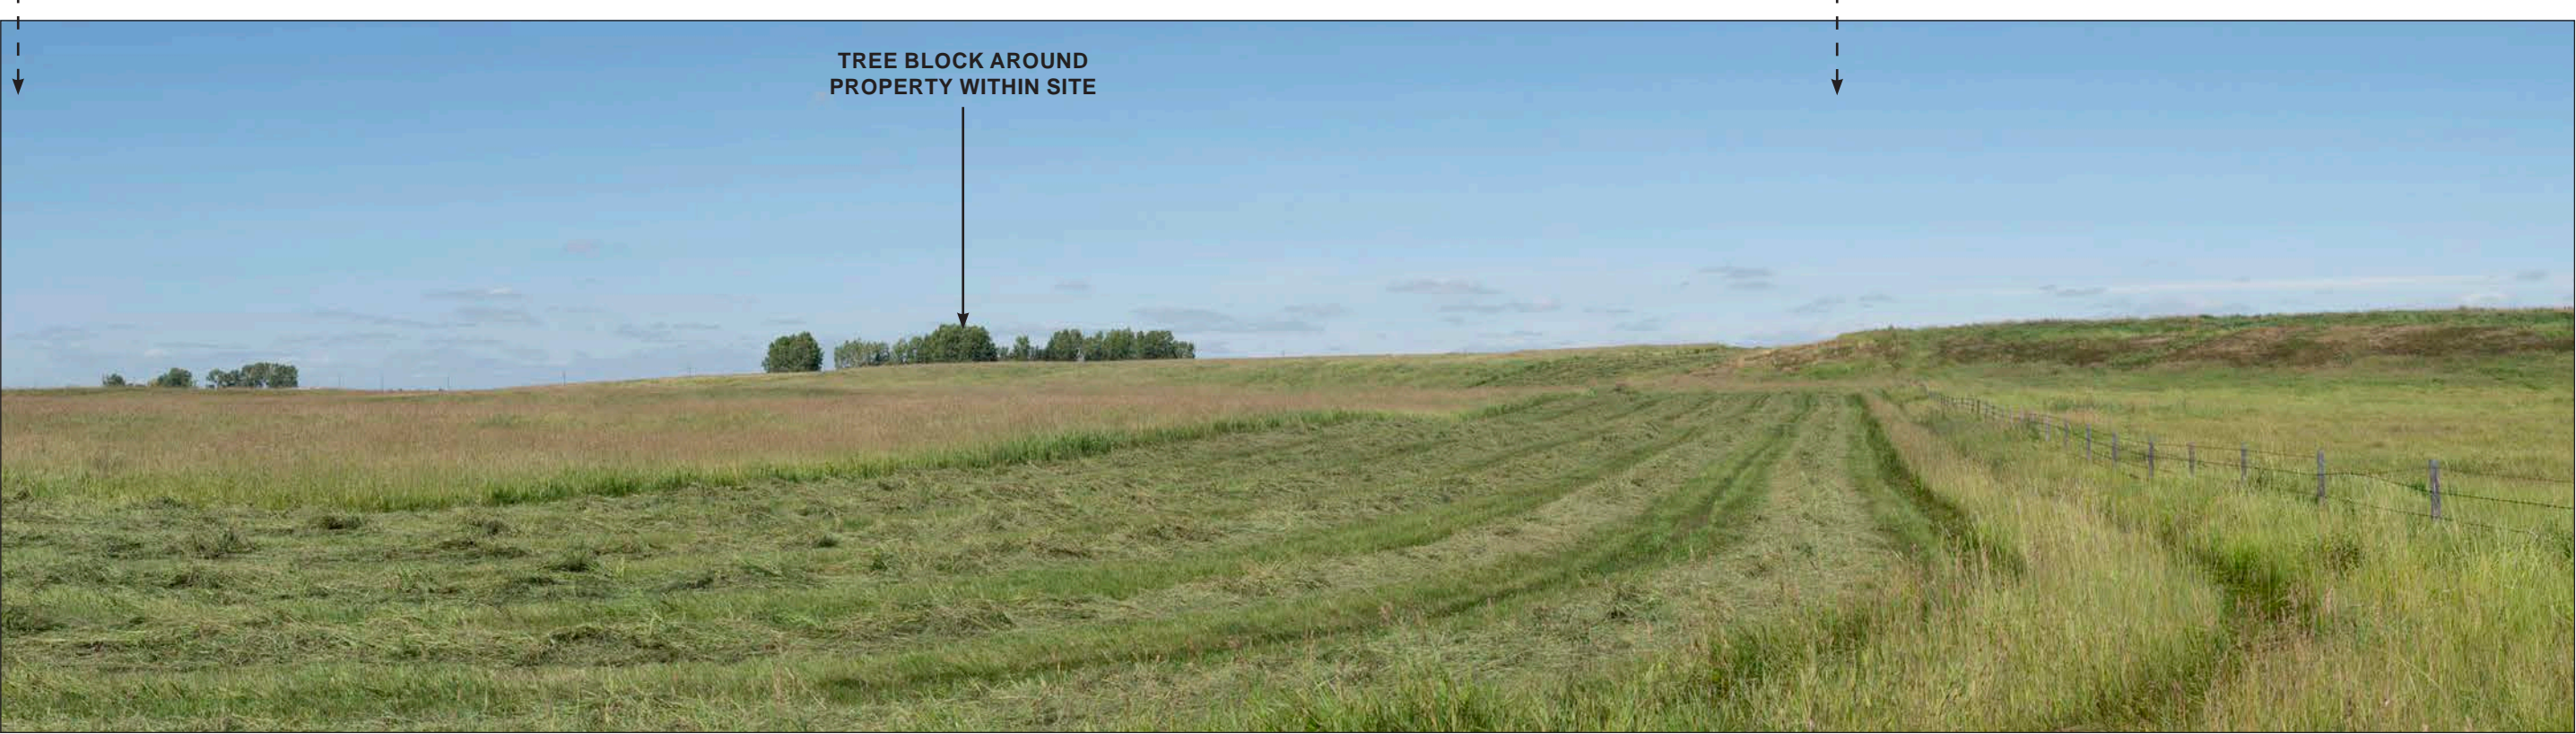
MOUNTAIN ASH	
	VISUAL APPRAISAL	
DRAWING 12		
Scale AS SHOWN	Date DECEMBER 2019

OPEN VIEWS TOWARDS SITE (MAINLY FARMING LANDUSE)

VIEWPOINT 5 (CONTINUED): AT EASTERN EDGE OF SITE, LOOKING NORTH-WEST.

VIEWPOINT 5 (CONTINUED): AT EASTERN EDGE OF SITE, LOOKING NORTH.

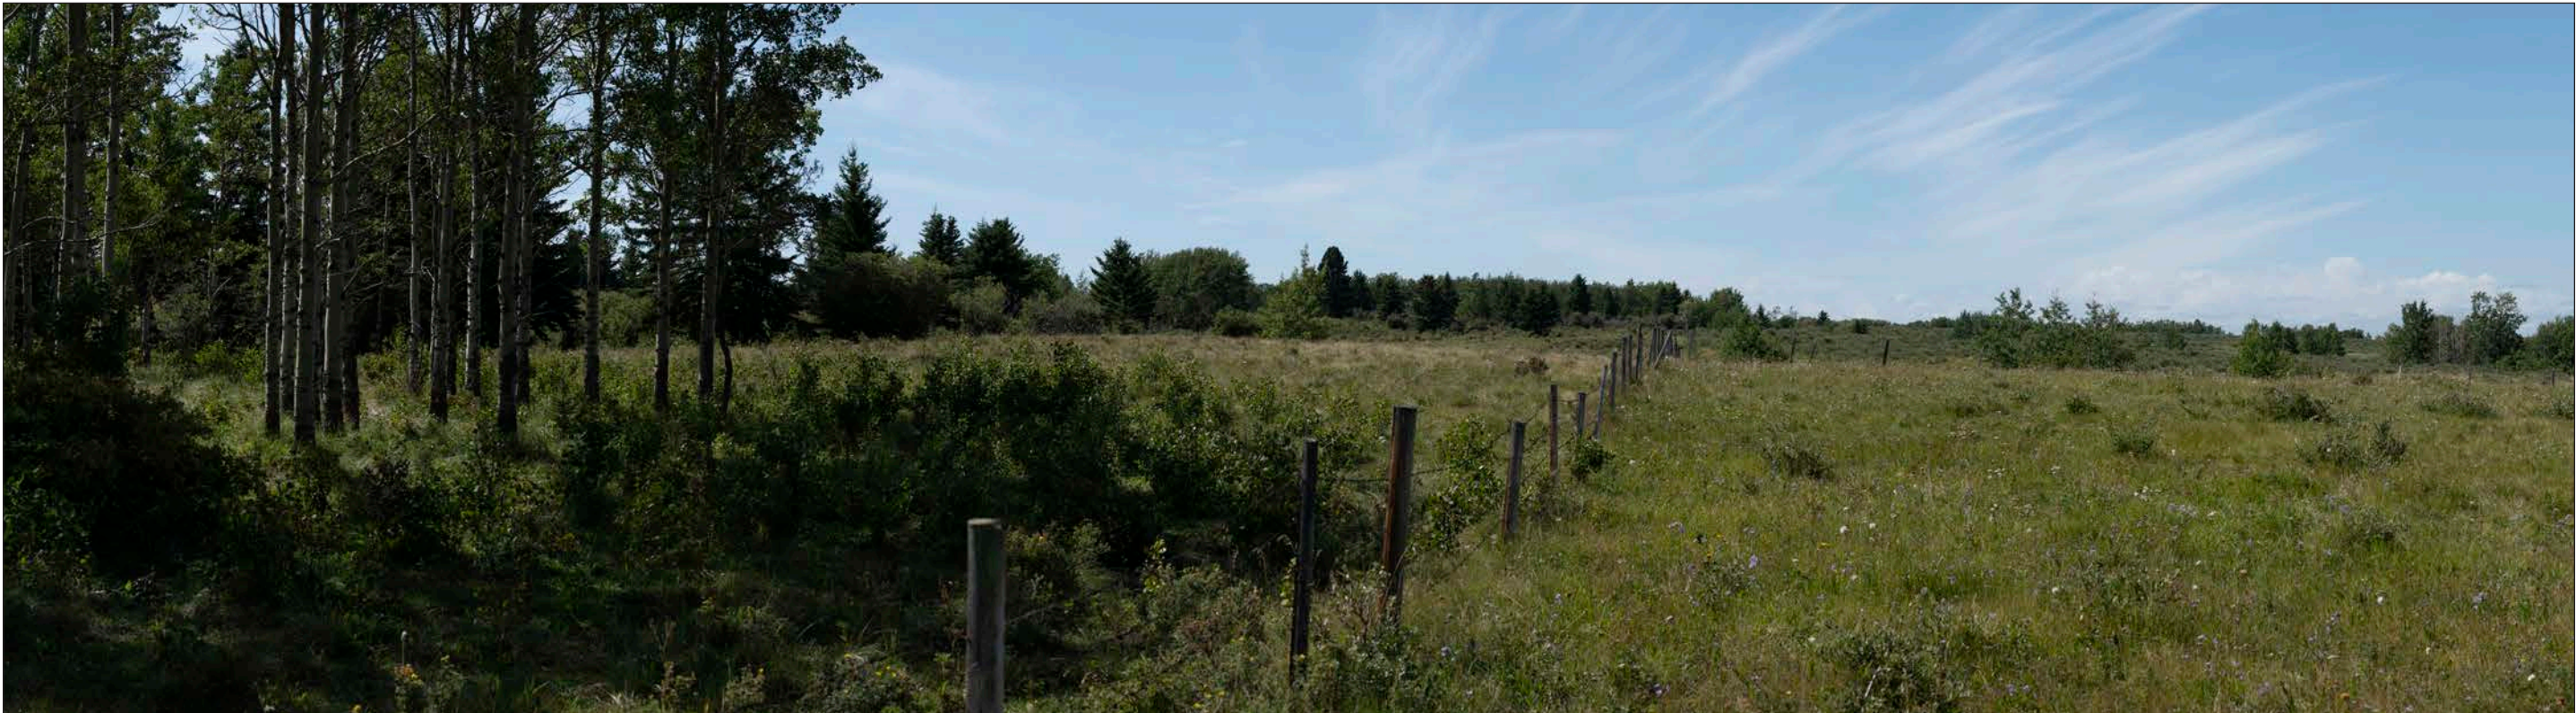
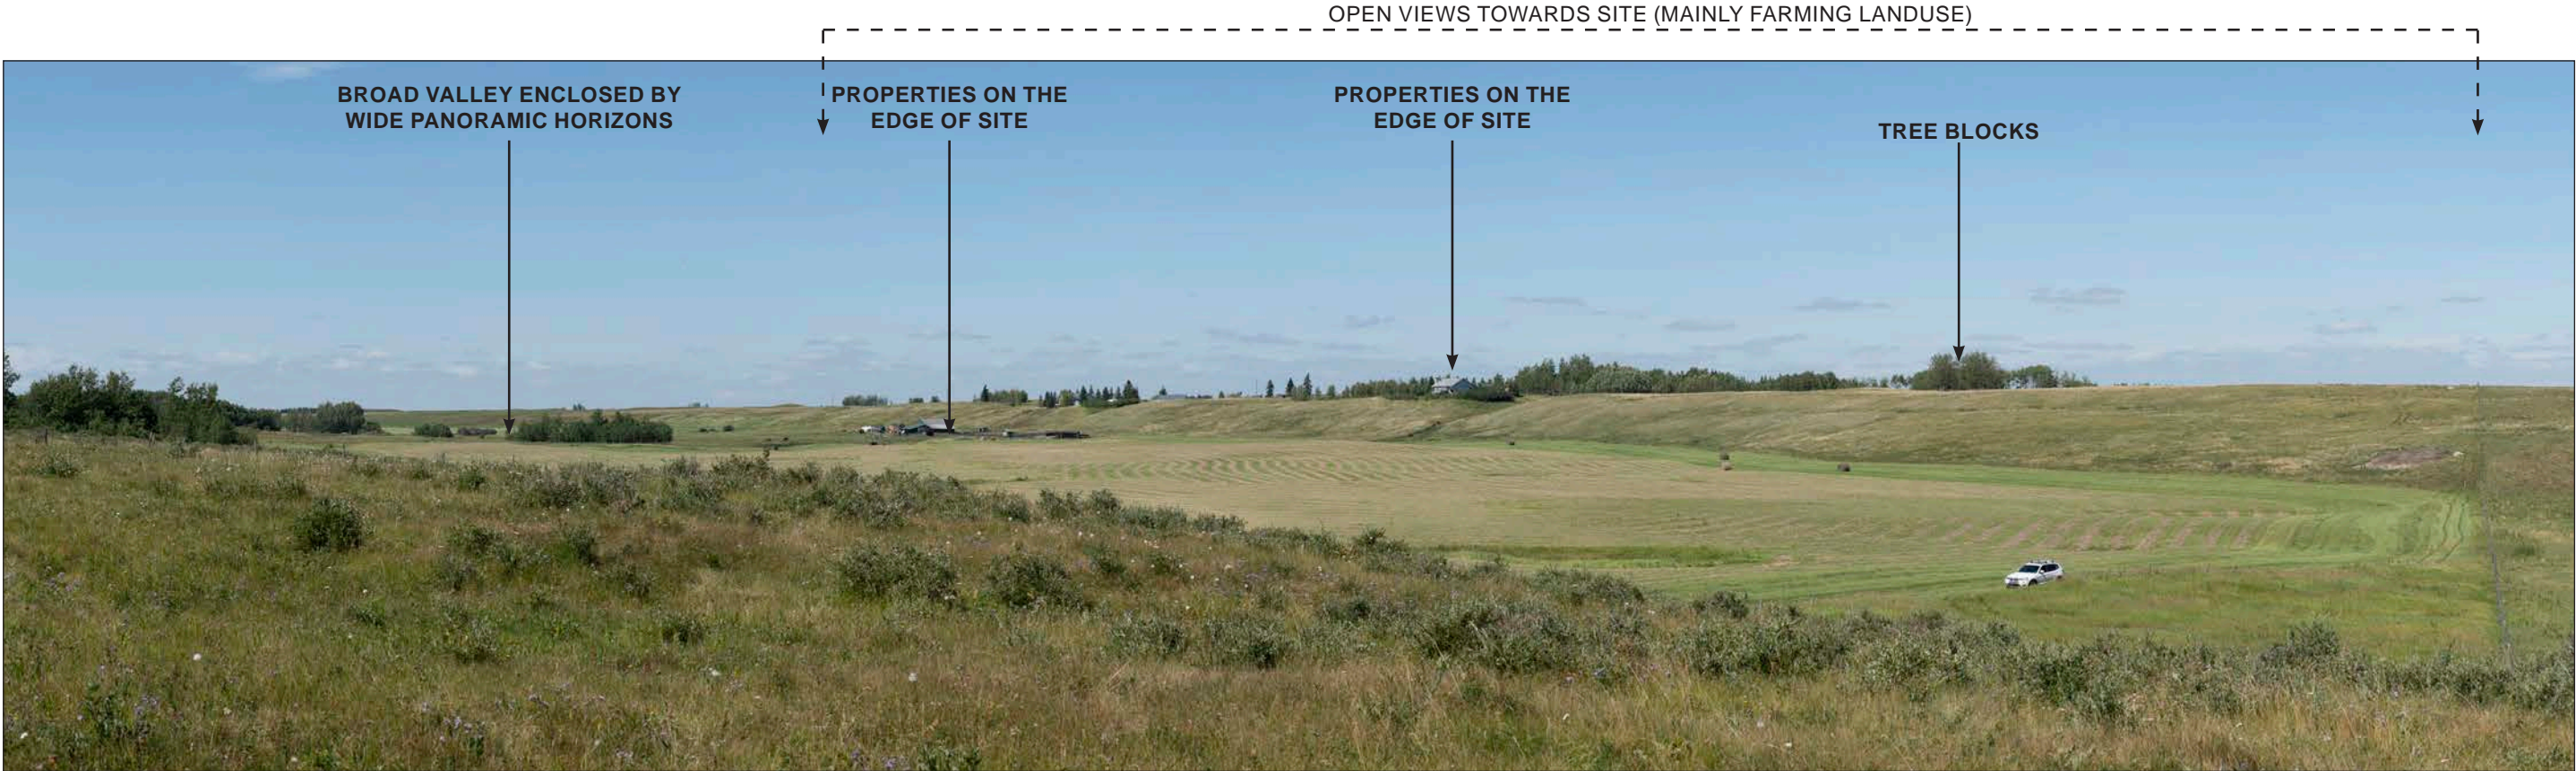
MOUNTAIN ASH <hr/> VISUAL APPRAISAL <hr/> DRAWING 13	
	Scale AS SHOWN	Date DECEMBER 2019

VIEWPOINT 6: SOUTH-EAST CORNER OF SITE, LOOKING WEST.

VIEWPOINT 6 (CONTINUED): SOUTH-EAST CORNER OF SITE, LOOKING NORTH-WEST.

As shown by Viewpoint 2 and 6, south of the site boundary is a broader c350m wide low-relief valley feature also sloping northwest to southeast and the two valley features converge approximately 700 m south-east of the site.
