**Mountain Ash Limited Partnership Aggregate Operation
NW and SW 31-26-03 W5M, Rocky View County, Alberta**

Visual Appraisal

**February 2020
SLR Project No.: 212.06650.00003/008**

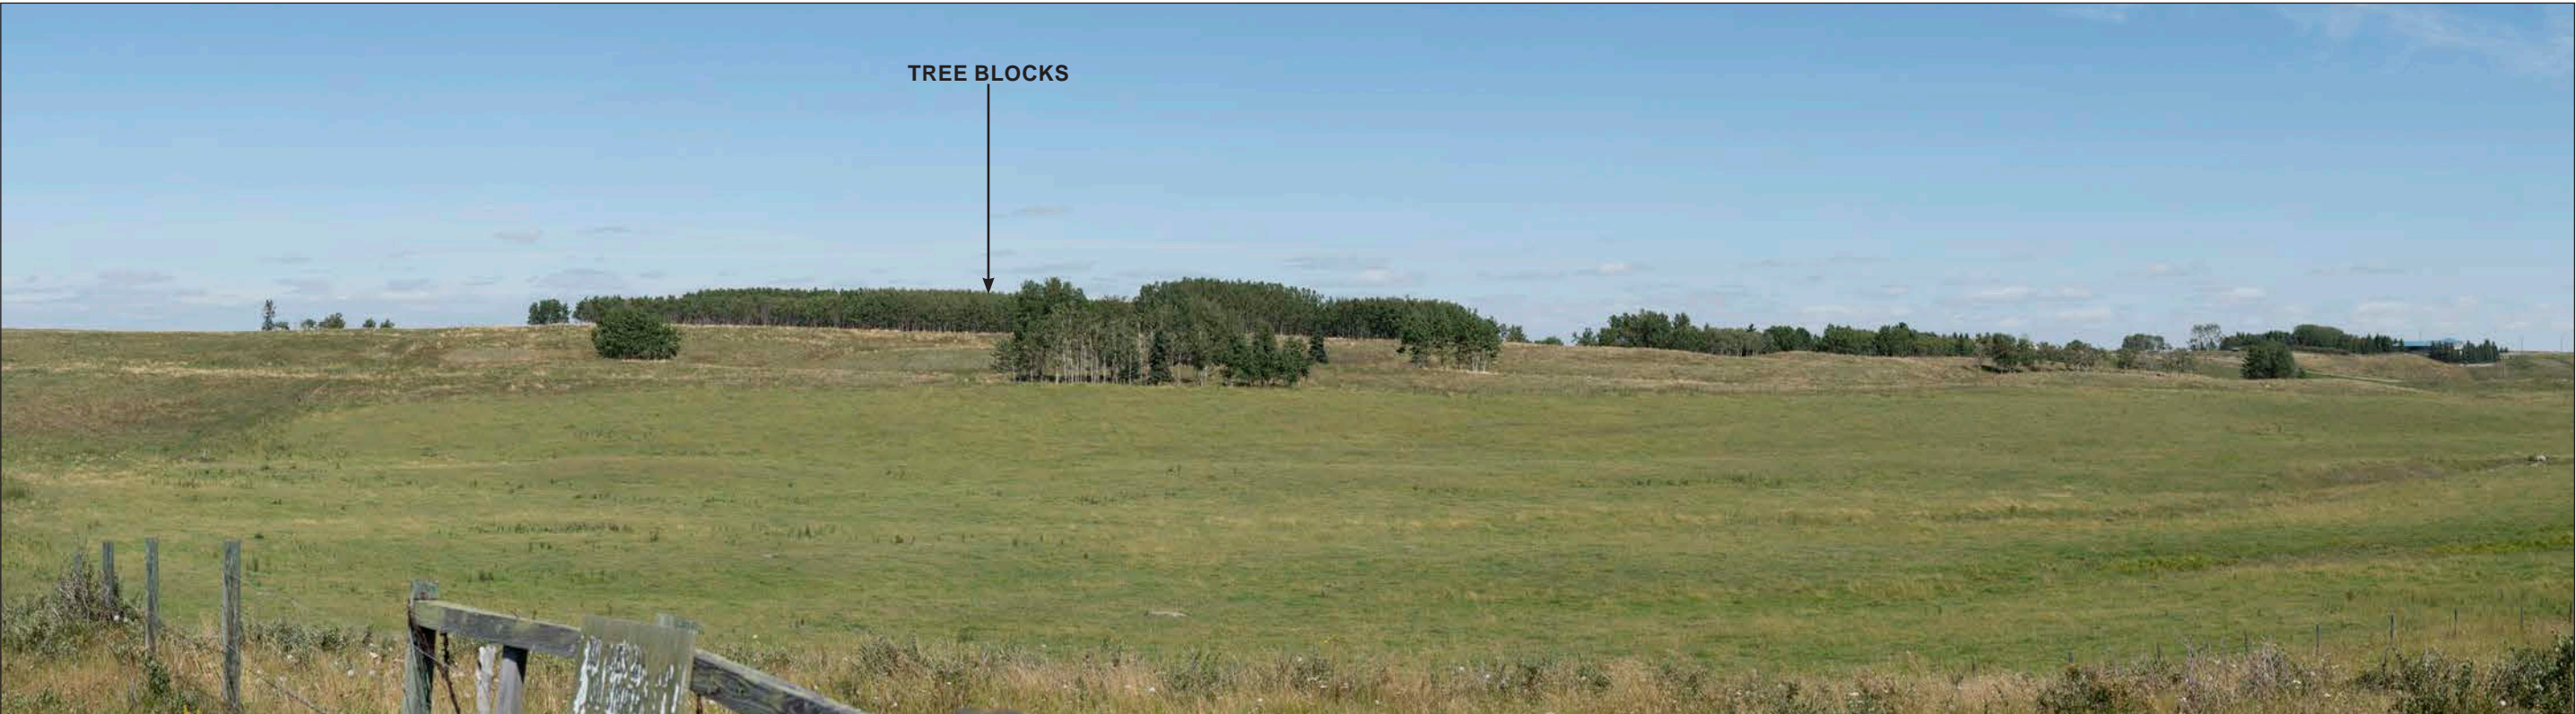
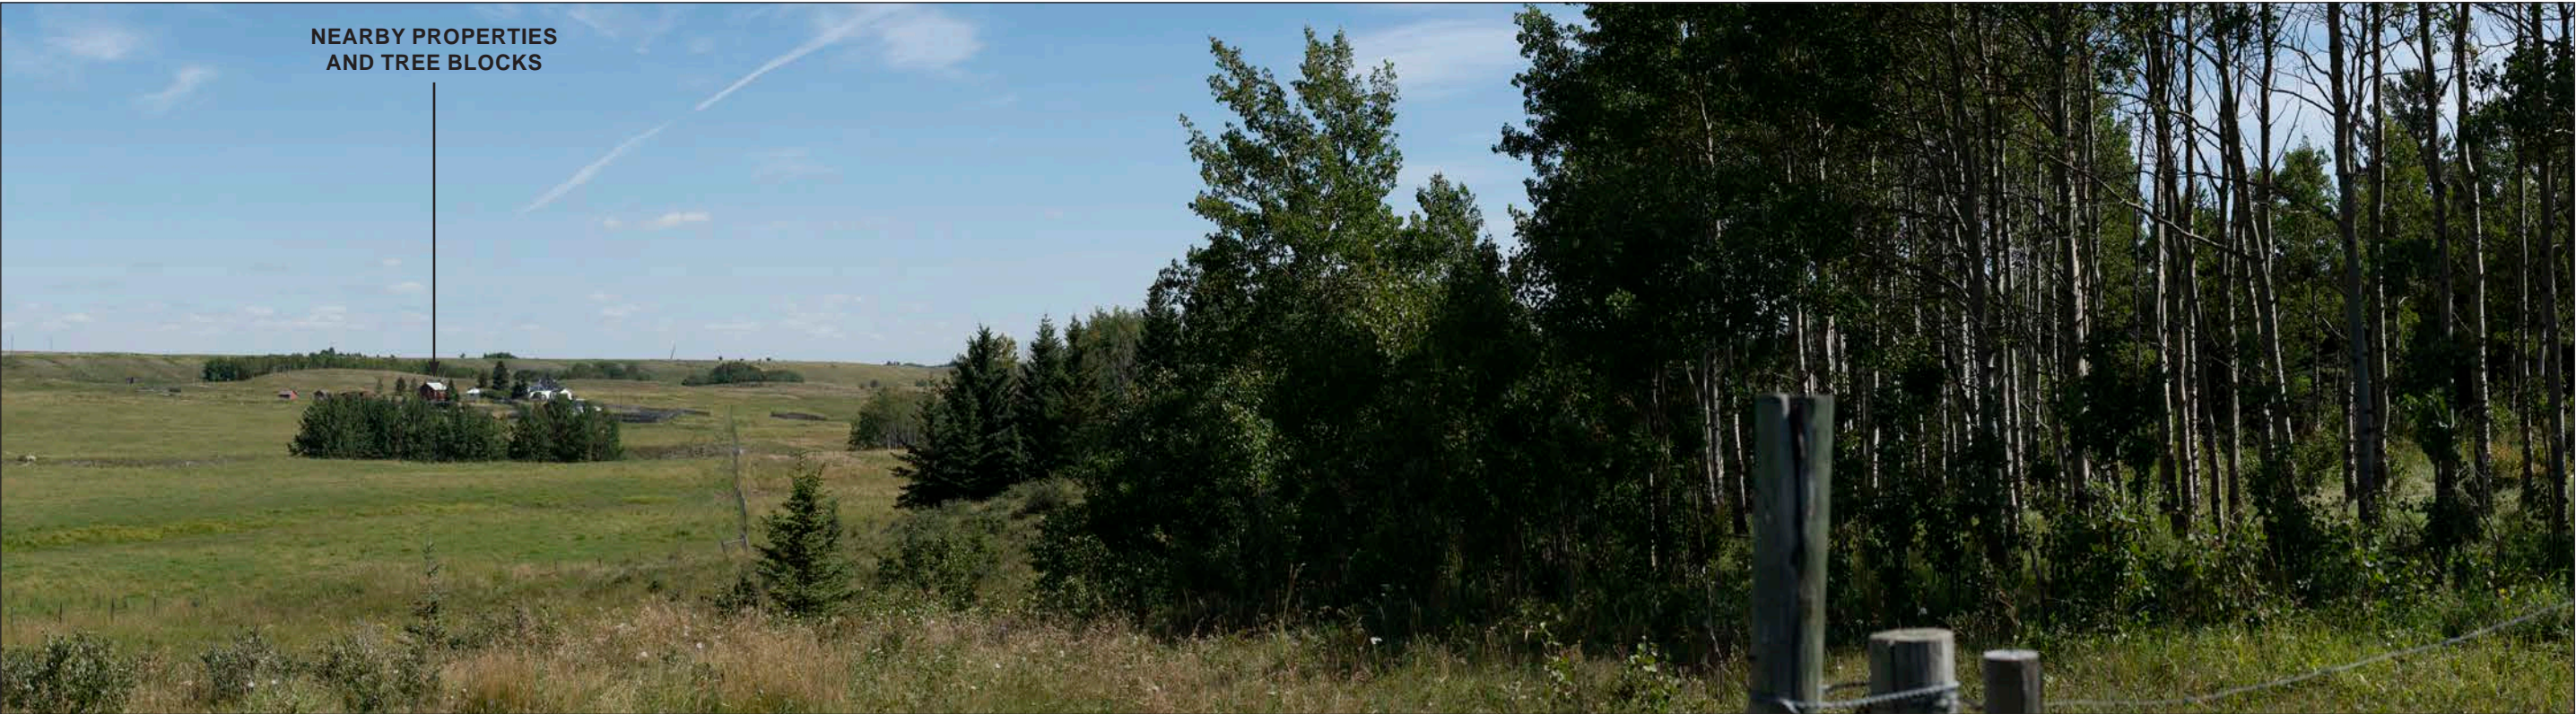
MOUNTAIN ASH	
	VISUAL APPRAISAL	
	DRAWING 14	
Scale AS SHOWN	Date DECEMBER 2019

VIEWPOINT 6: SOUTH-EAST CORNER OF SITE, LOOKING NORTH-EAST.

VIEWPOINT 6 (CONTINUED): SOUTH-EAST CORNER OF SITE, LOOKING EAST.
