Code of Practice for Pits in Alberta Application – REVISED

Mountain Ash Limited Partnership

Summit Pit

SLR Project No: 212.06650.00007/8

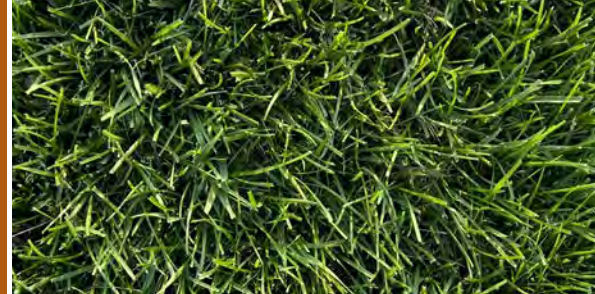
ScourStop® Installation Recommendations

1. ScourStop mats must be installed over a soil cover: sod, seeded turf reinforcement mat (TRM), geotextile, or a combination thereof.
2. For steep slopes (>10%) or higher velocities (>10 ft/sec), sod is the recommended soil cover.
3. Follow manufacturer's **ScourStop Installation Guidelines** to ensure proper installation.
4. Install ScourStop mats at maximum 1-2" below flowline of culvert or culvert apron. (No waterfall impacts onto ScourStop mats.)
5. Performance of protected area assumes stable downstream conditions.
